## Geohazard Assessment of the Old Fort Area

PRESENTED TO  
**Peace River Regional District**

JUNE 24, 2021  
ISSUED FOR USE  
FILE NO. 704-ENG.VGEO3774-01  
REVISION 1

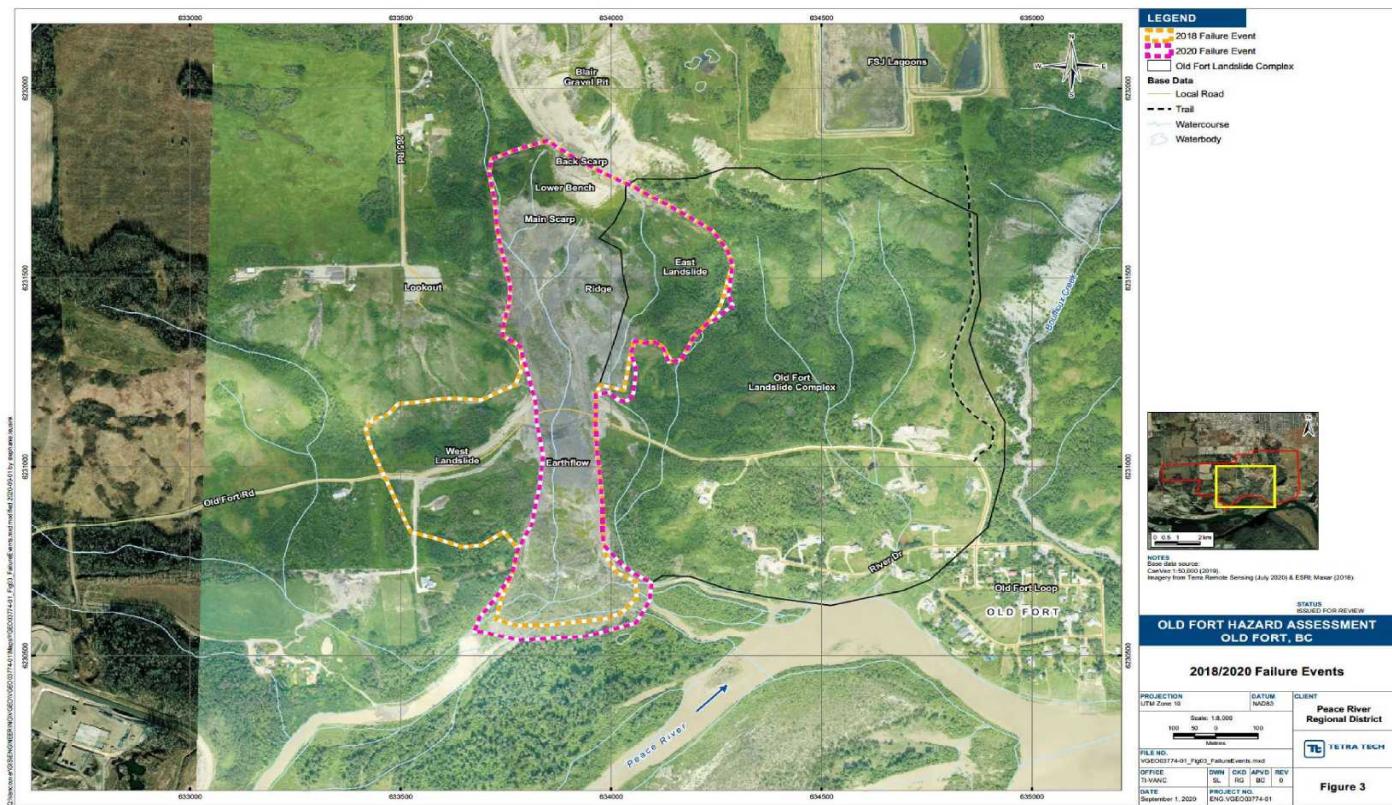
Figure 3: 2018/2020 Failure Events

The extent of the 2018 and 2020 landslide events is shown on Figure 3.

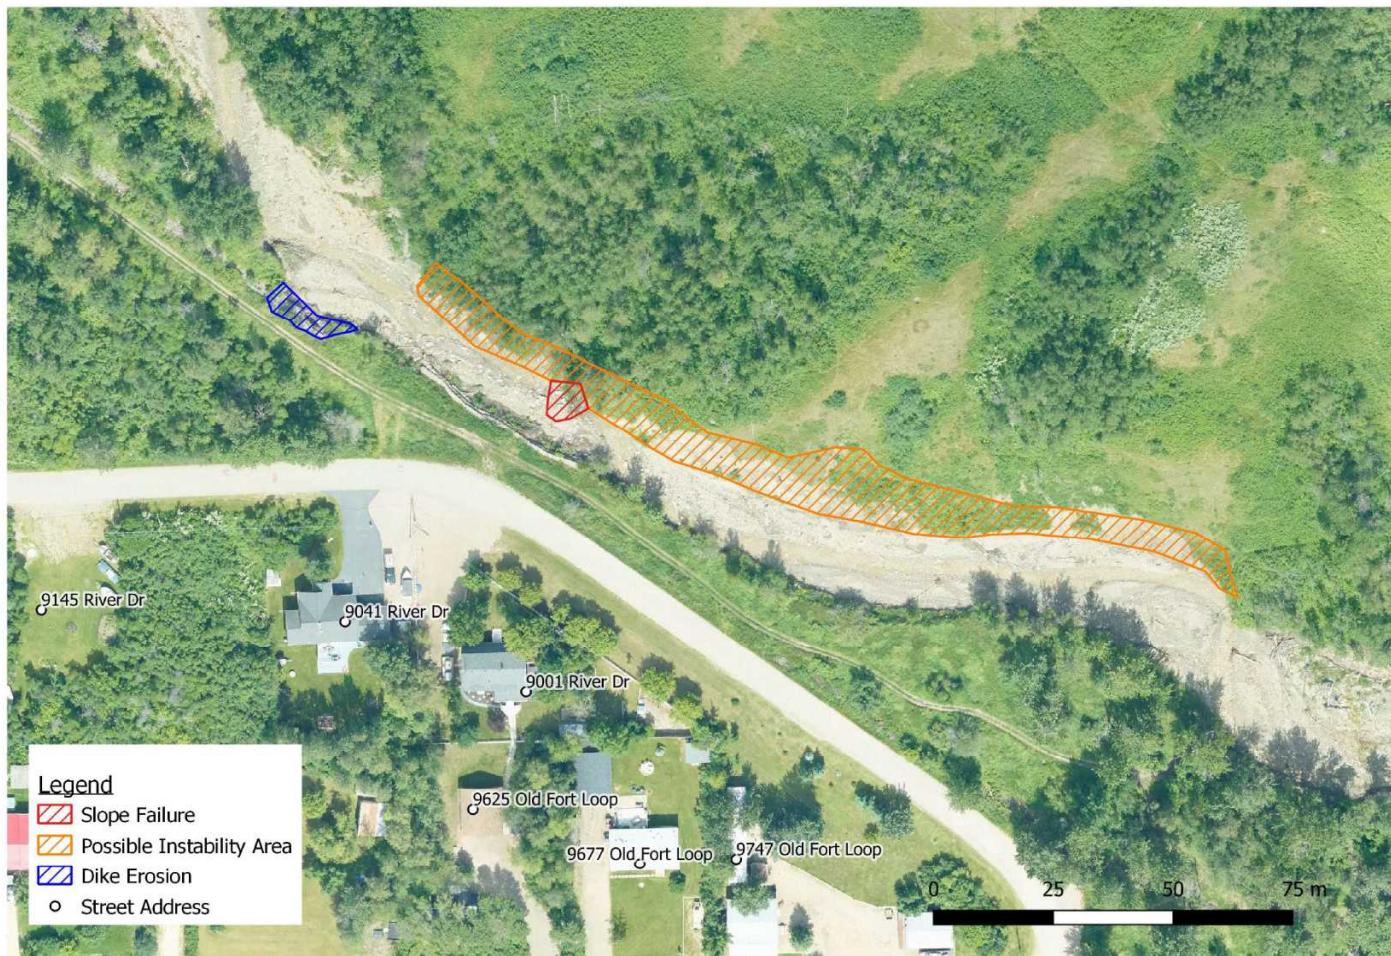
**Figure 4: Bank Instability and Dike Erosion Locations**

The inside bend of Bouffioux Creek in proximity to where the creek transitions from south flowing to east flowing adjacent to Old Fort is susceptible to slope instabilities. A small failure partially blocking the creek was observed when Tetra Tech was on-site in July of 2020 (see Photos 50 and 51 in Appendix C). The location of the dike erosion and small failure are shown on Figure 4 below. A larger failure at this location could dam the creek and cause overtopping of the dike resulting in flooding into the Old Fort.

The main ongoing hazard for Bouffiox Creek is a continued destabilization and failure of the Bouffiox Creek valley walls and bank slopes. It is possible a landslide event could temporarily block the creek channel and then release a large volume of water as a debris flood/outburst flood event. Reactivation of the large compound slide on the east slopes of Bouffiox Creek could block the creek resulting in a large volume of water being impounded and eventually a large outburst flood.

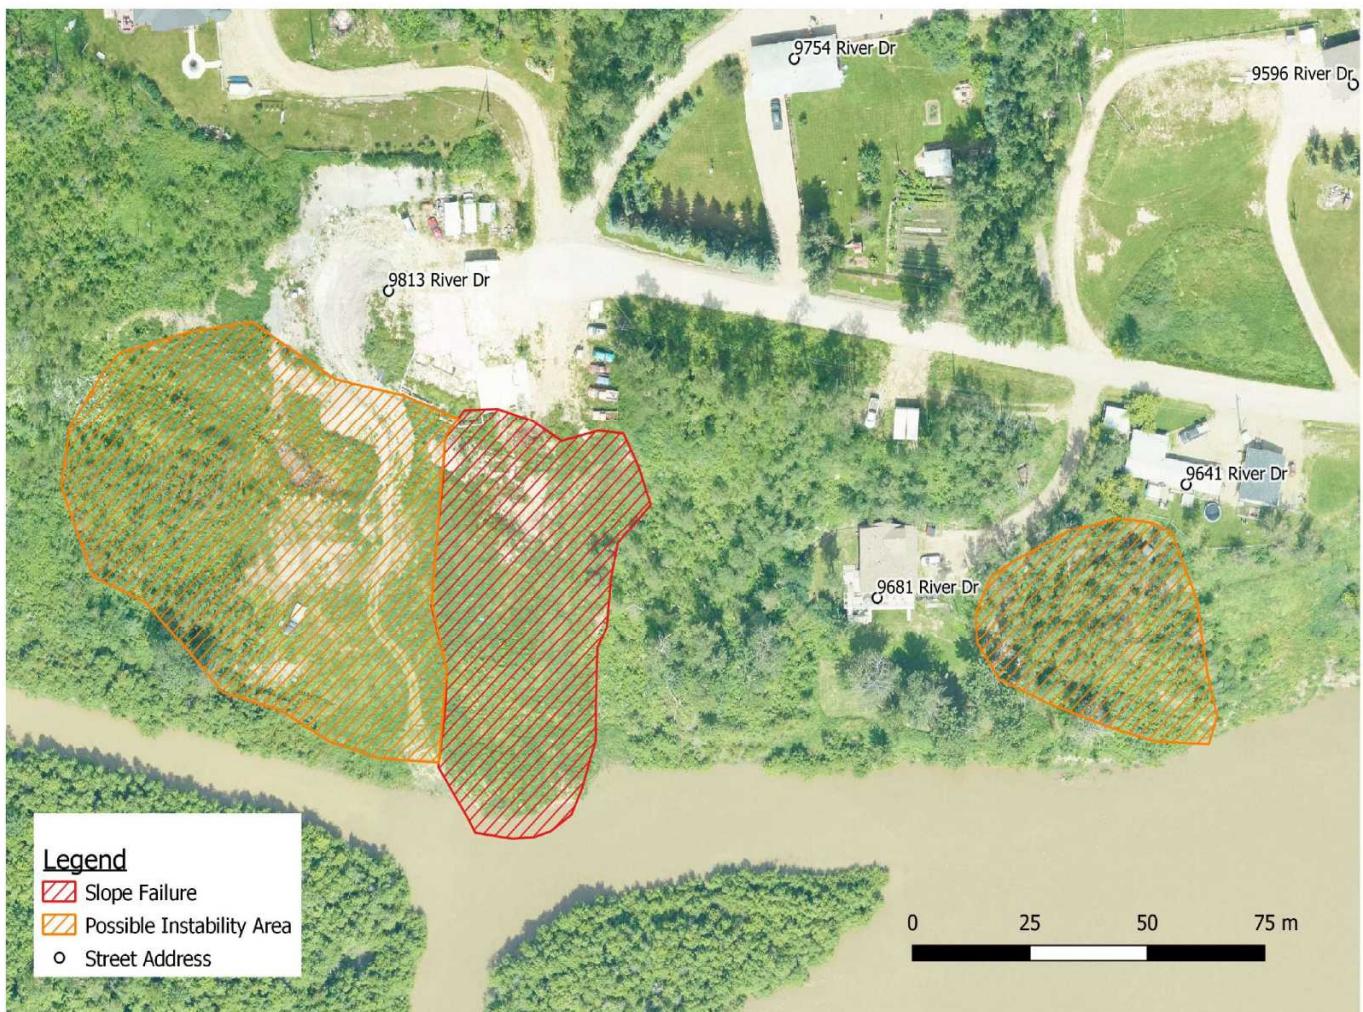
**Figure 5: River Drive Instabilities**

Based on LiDAR data, a slope failure along the south facing slopes of the riverbank below 9813 River Drive initiated between 2012 and 2015, and additional failures and landslides occurred between 2015 and 2018. No discernible movement occurred between 2018 and 2020 LiDAR datasets. Areas affected by slope movements are shown on Figure 5 below. An additional area below 9641 River Drive and adjacent to 9681 River Drive is also highlighted as an area of possible bank instability based on surface texture of the slope.

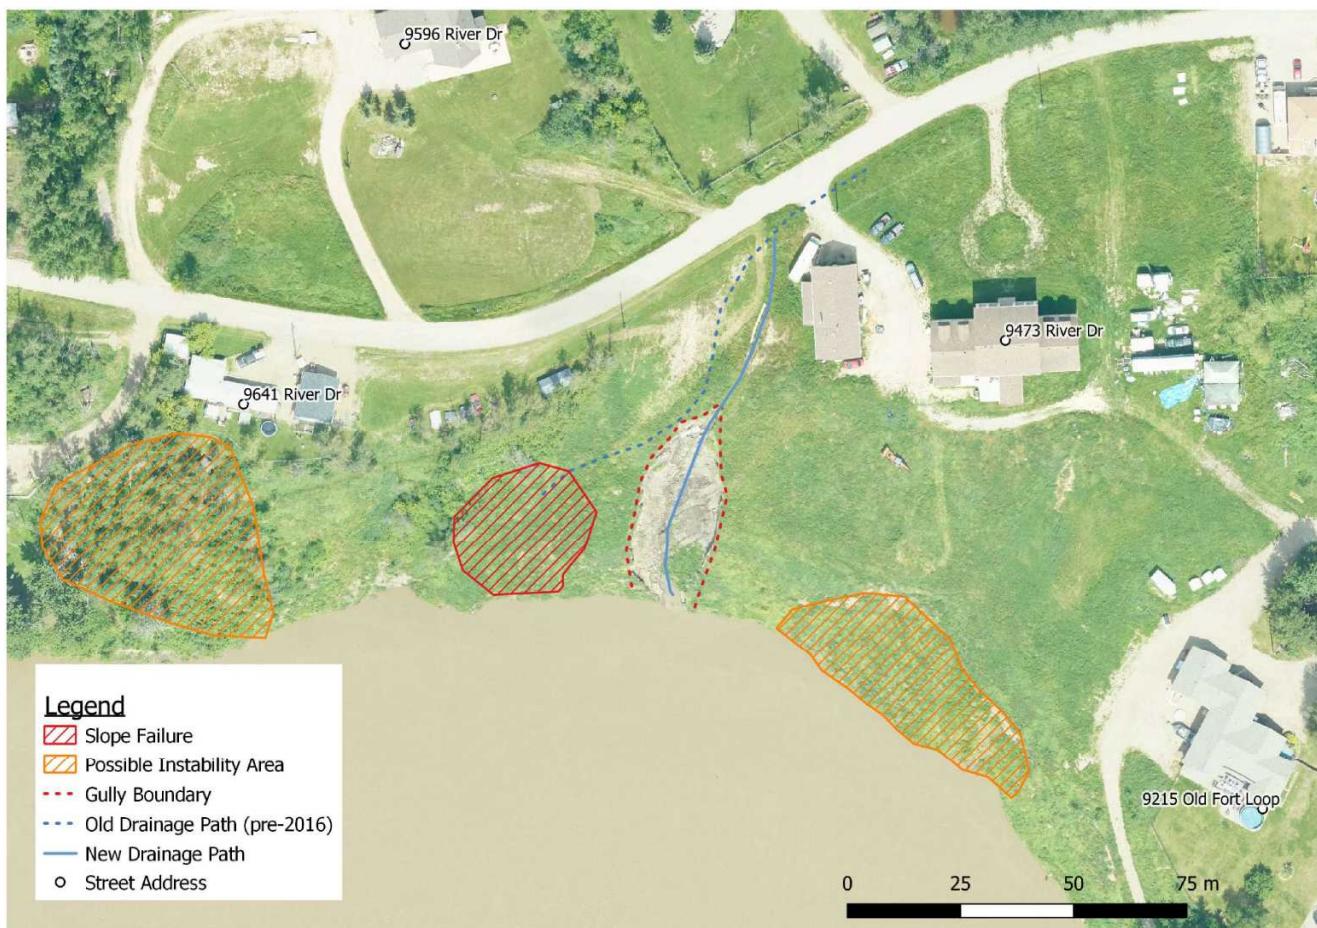
**Figure 6: Gully forming south of River Drive on Peace River slope**

A gully has formed at the south west corner of 9473 River Drive lot. The gully was first visible on Google Earth imagery from 7/29/2017. Based on LiDAR data, the gully has regressed approximately 10 m between 2018 and 2020.

The 2015 LiDAR dataset shows a slope failure at the east end of the 9641 River Drive property at the location where a drainage path entered the Peace River. Google Earth imagery from 4/25/2016 shows site grading and possible slope repair and re-alignment of the drainage path at 9641 and 9473 River Drive. The drainage path was shifted 10 m to the east to the location of the current gully failure. Figure 6 below shows the location of the current gully failure and the location of the slope failure.

Recent bank failure and erosion below and adjacent to the properties highlight the ongoing bank erosion and slope instability hazard. The Peace River back channel that was blocked by the 2018/2020 earthflow events rejoins the Peace River near this location. There is uncertainty in how the earthflow landslide dam may affect river flow or change erosion patterns below the lots on River Drive adjacent to the Peace River.

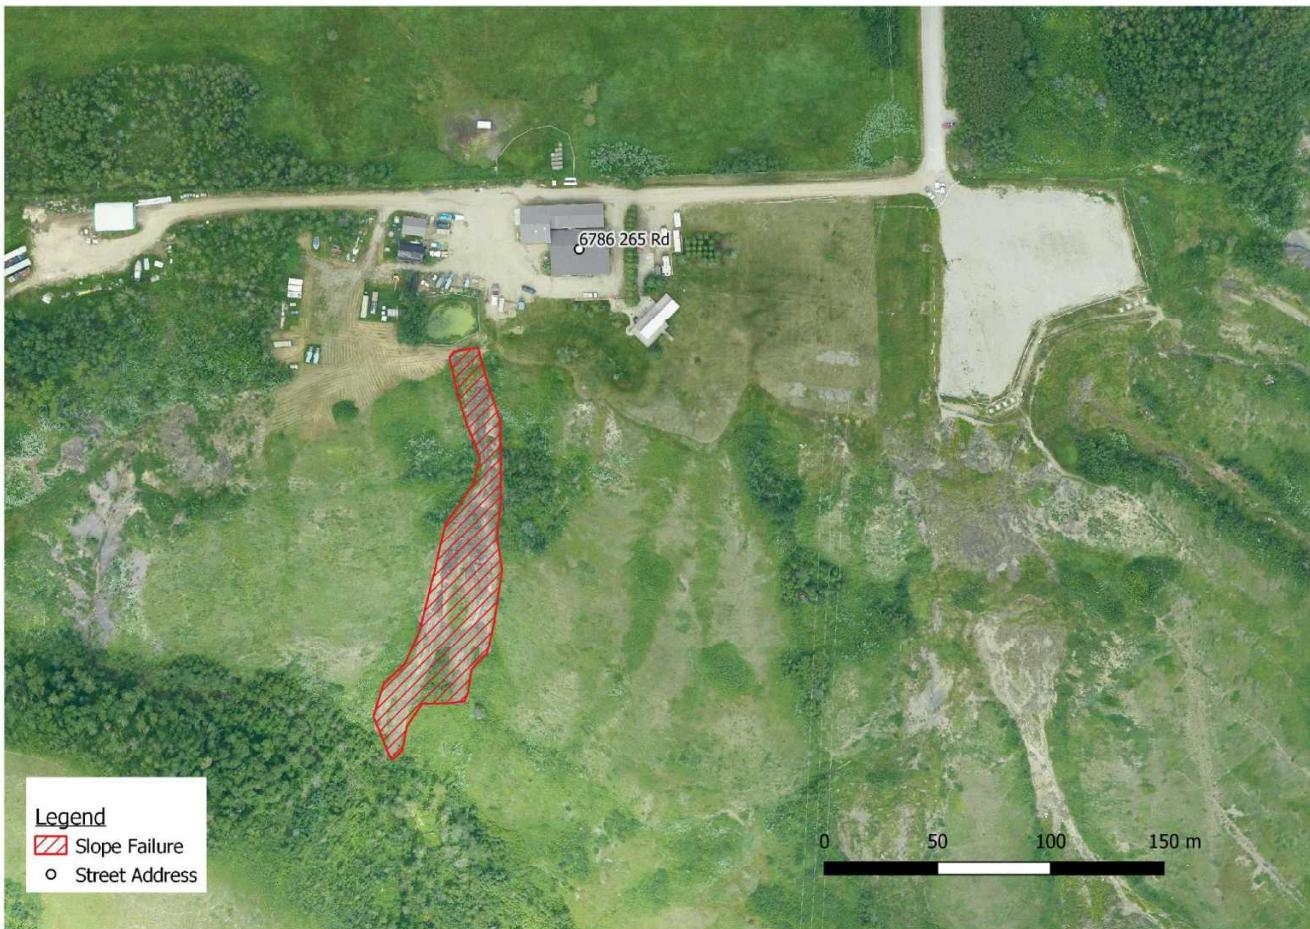
**Figure 7: Slope Failure below 6786 265 Road**

The slopes west of the 2018/2020 slope failures have had small landslide failures throughout the aerial photo/LiDAR record. The slopes to the south and east of the lookout at the south end of 265 Road are actively deforming. Based on field observations, the failures are shallow and appear to deform during wet periods/high rainfall events. During the field support for the 2020 failure event, a shallow earth slump/flow was observed on the south facing slopes below a pond at 6786 265 Road (see Photo 31 in Appendix C). Further regression of this failure could cause the pond to breach which could impact the properties downslope. Figure 7 below shows the failure location.

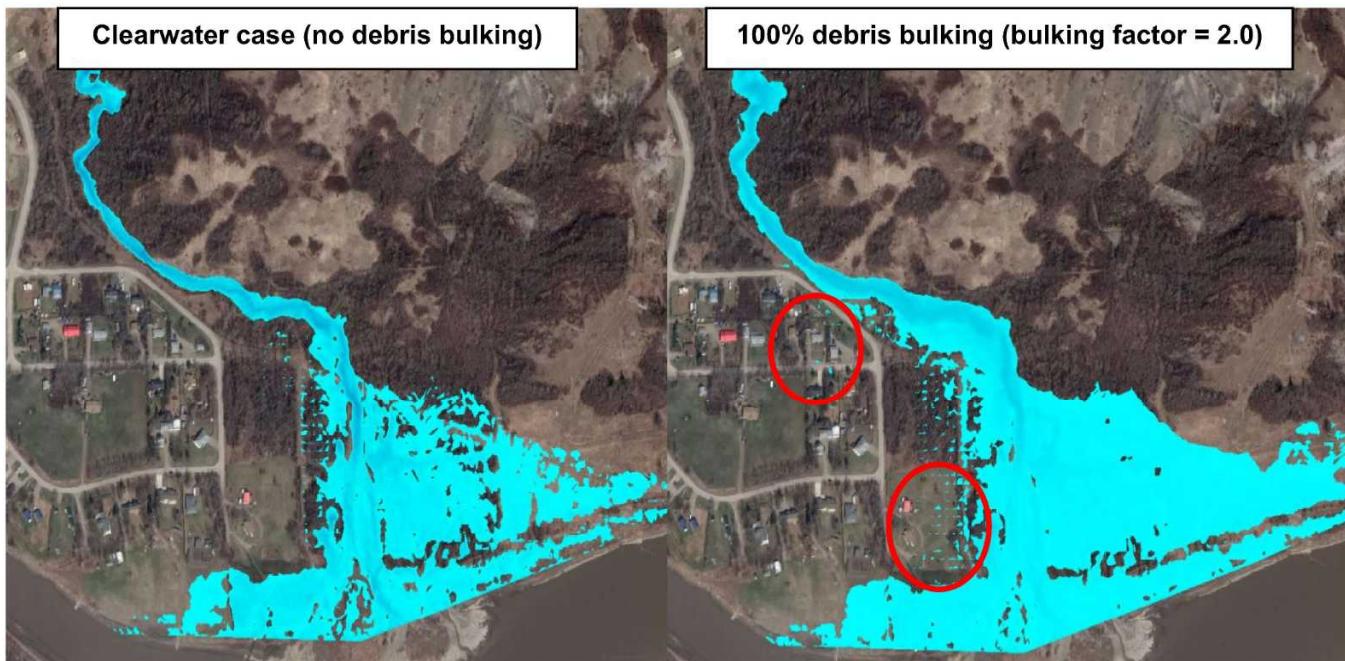
Figure 8: Predicted flooding extents for the clearwater (left), and debris-bulked (right) cases in Old Fort

It was found that no significant flooding occurs in the Old Fort Area for a clearwater (no debris) case. However, by including the effect of debris-bulking it was found that flooding occurs south of the dike alignment at the north end of Old Fort. The predicted flooding extents for the clearwater, and debris-bulked scenarios are shown below on Figure 8.

In agreement again with the 2004 and 2013 Urban Systems reports, it is likely that this debris-bulked scenario will be the more likely case in the future, and may worsen over time as FSJ continues to develop and urbanize the upstream land, coinciding with the stormwater system upgrades which would increase discharge into the creek.

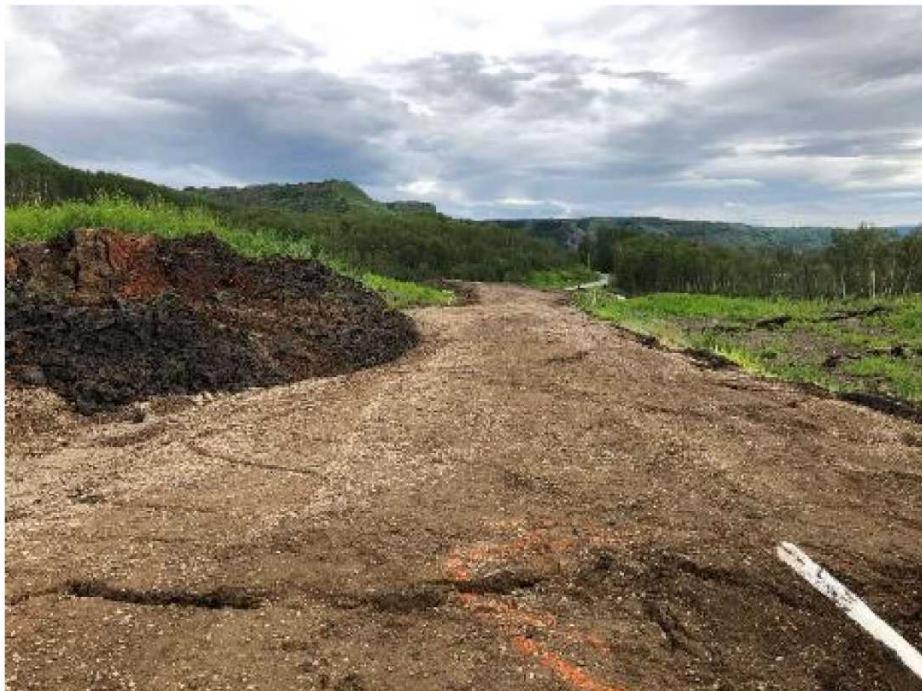
**Photo 3:** Old Fort Road being pushed to the south (note: tension cracks and earthflow bulge)  
June 20, 2020

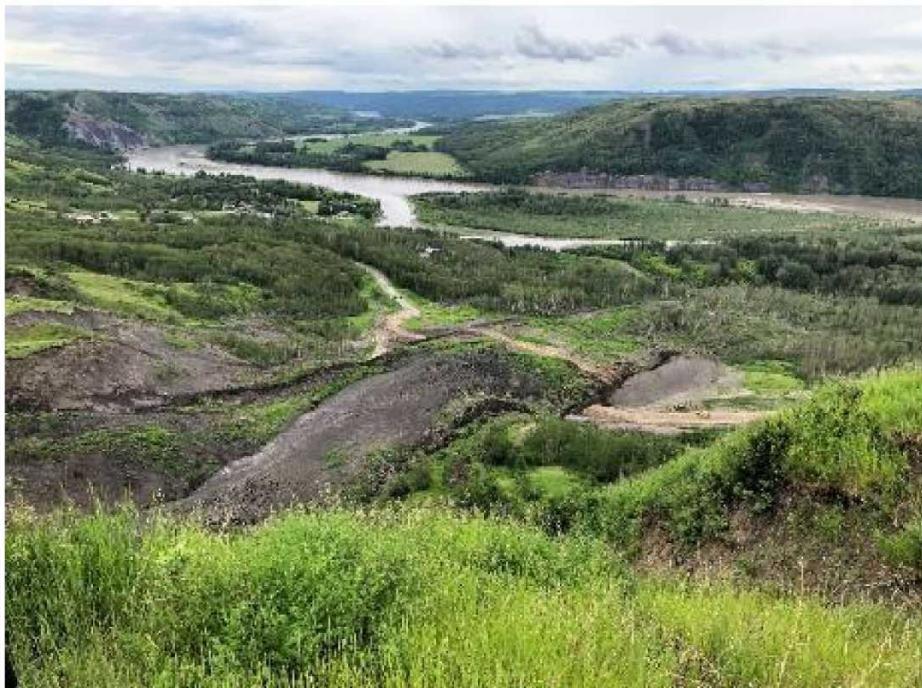
**Photo 4:** View of Old Fort Road displacement looking south from the look-out.  
June 20, 2020

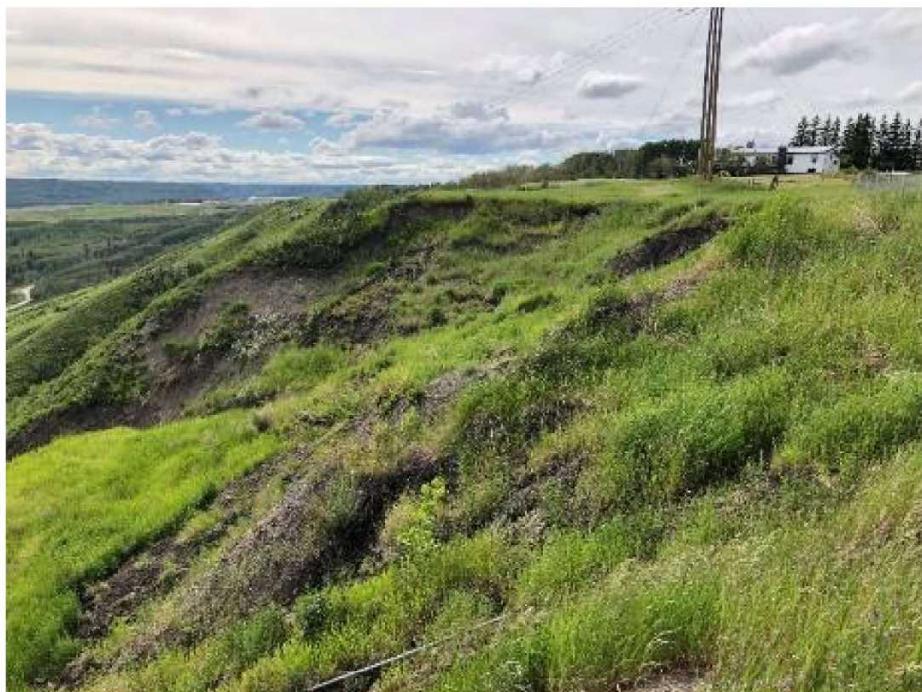
**Photo 8:** Slope relaxation and surface failures on the steep slopes on the south end of the look-out.

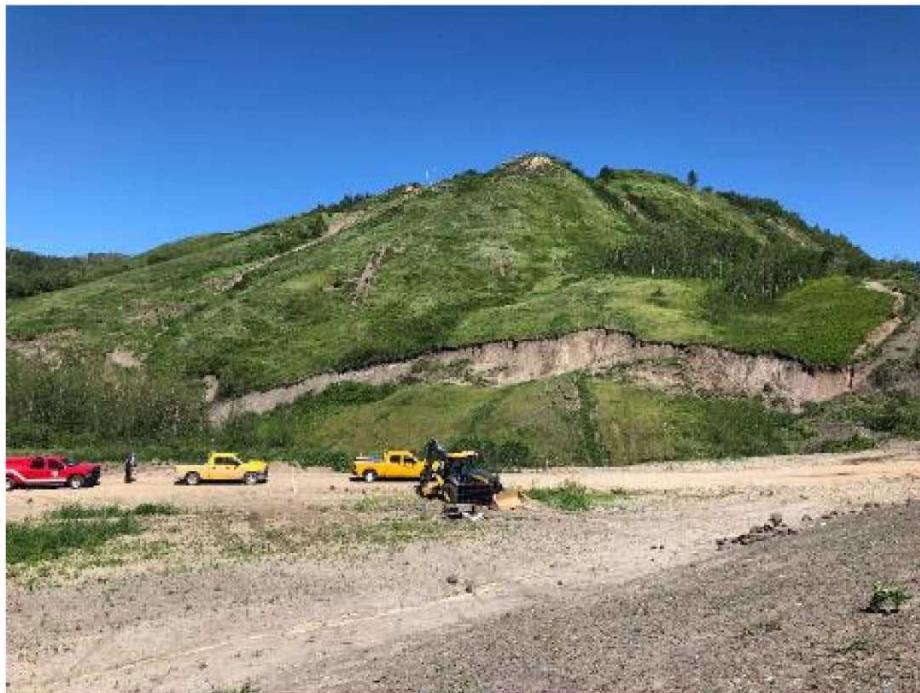
**Photo 9:** Picture from Old Fort Road, looking north/up to the look-out – scarp from 2018 west landslide failure.  
June 21, 2020

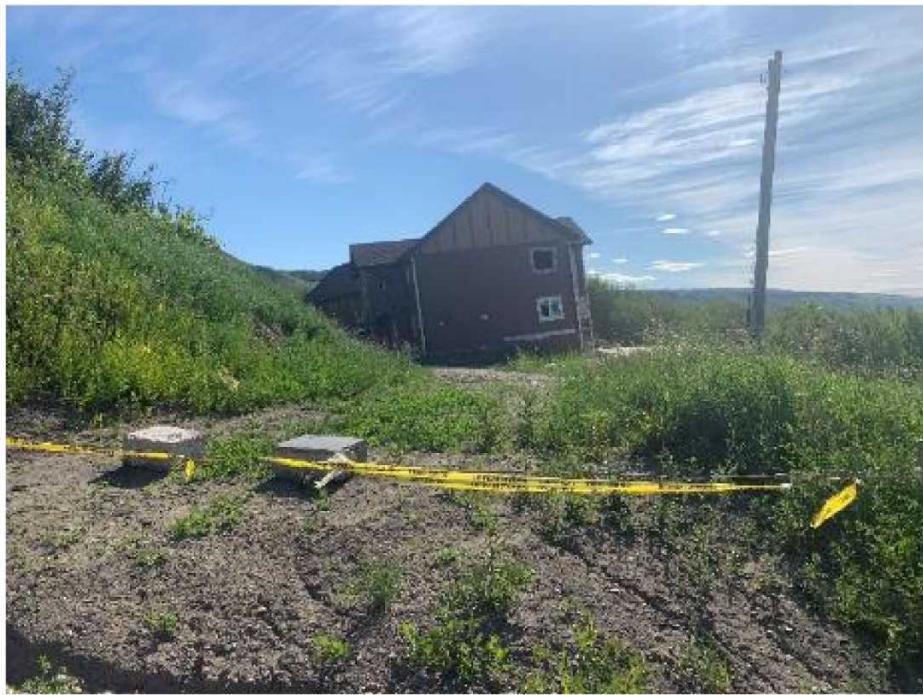
**Photo 11:** Photo of house damaged by 2018 landslide.  
June 22, 2020

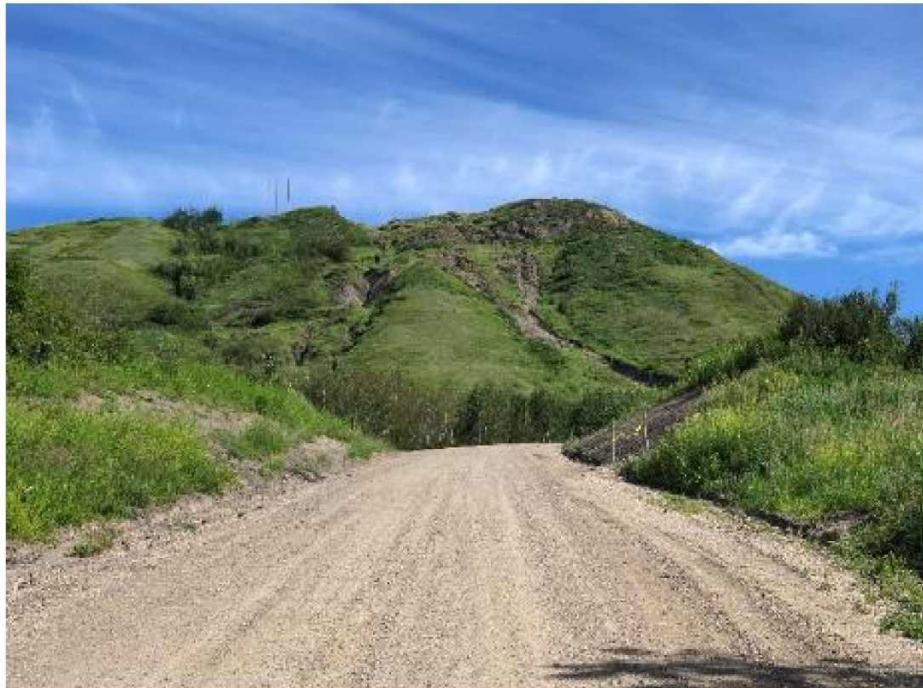
**Photo 12:** View of south facing slopes (below look-out). Multiple surface instabilities (shallow slump-flows).  
June 22, 2020

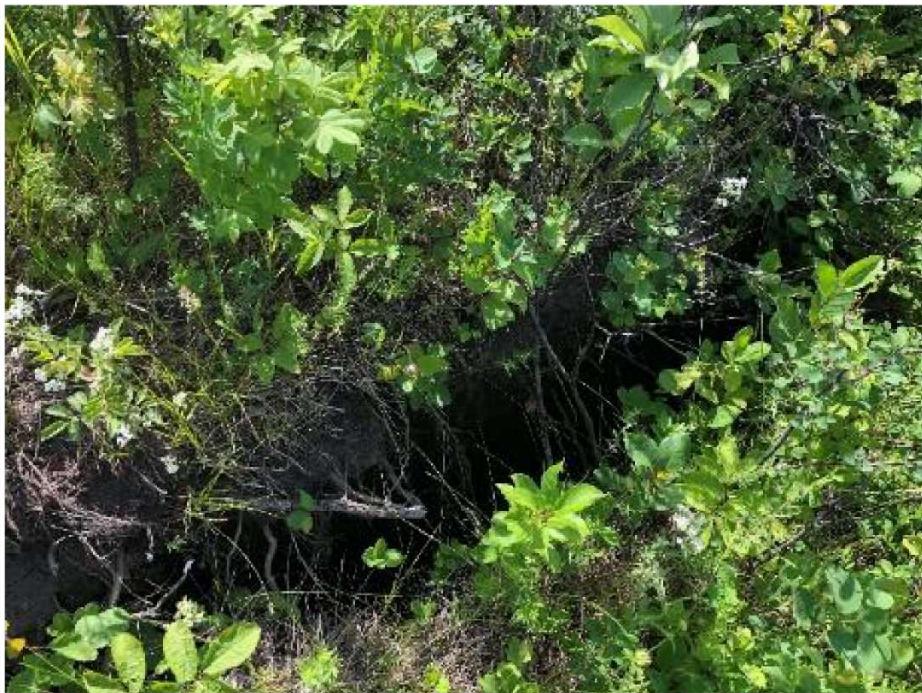
**Photo 13:** Deep tension cracks (approximately 6' deep) on west boundary of west landslide which occurred in 2018.

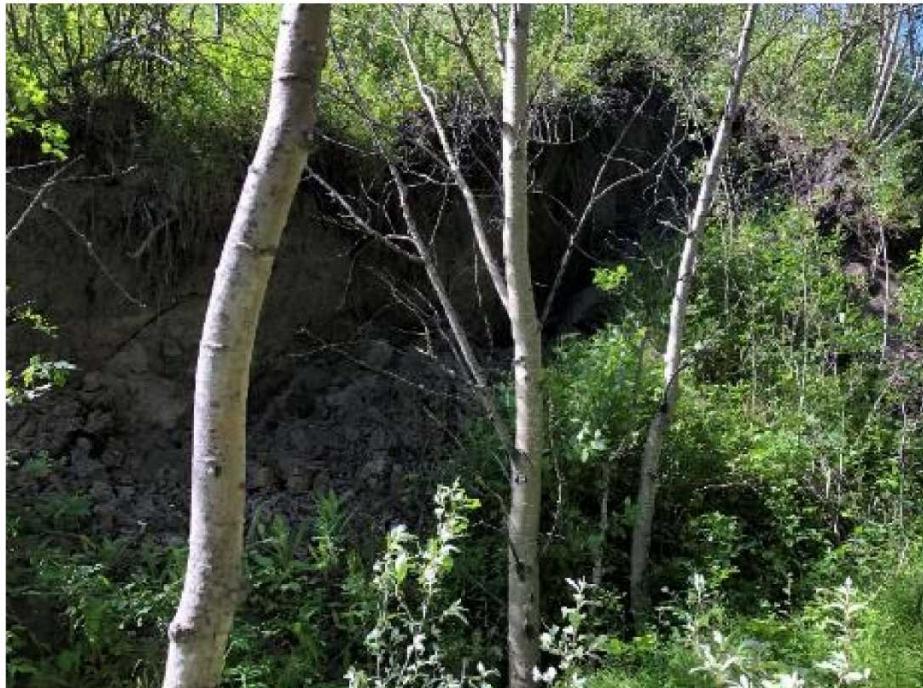
**Photo 16:** Exposed soil (cracks) from surface deformation on east side of ridge  
June 23, 2020

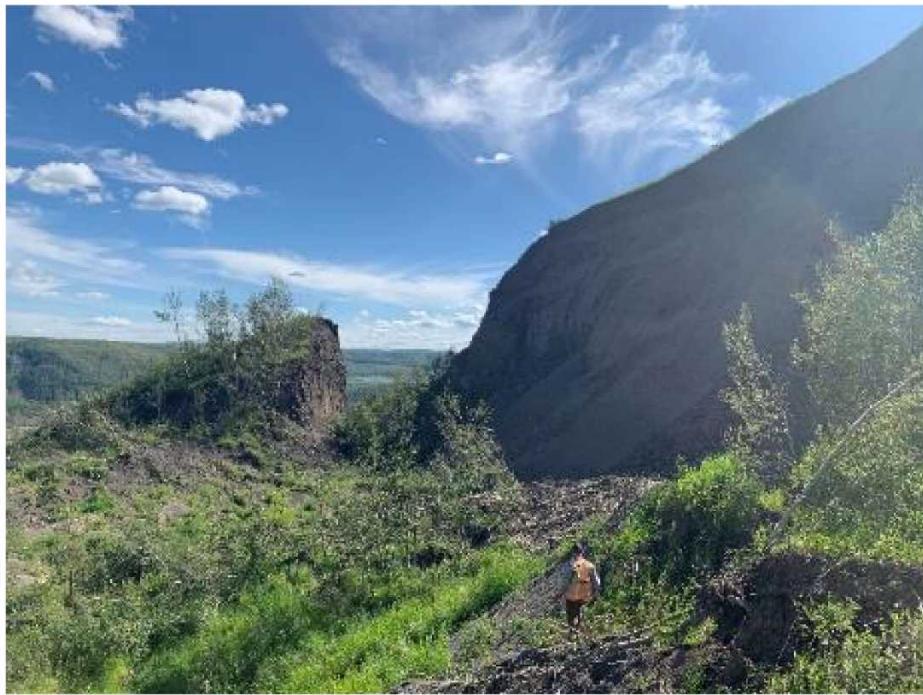
**Photo 17:** Backside of ridge – ridge was splitting and failing.  
June 23, 2020

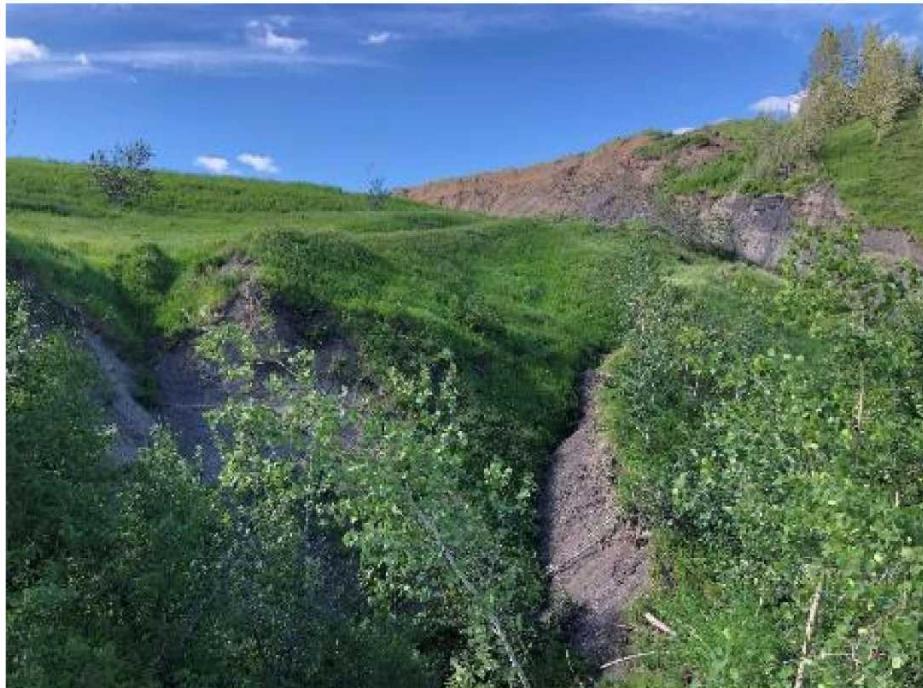
**Photo 18:** Tension cracks forming on south-east side of borrow pit platforms due to landslide deformation.  
June 23, 2020

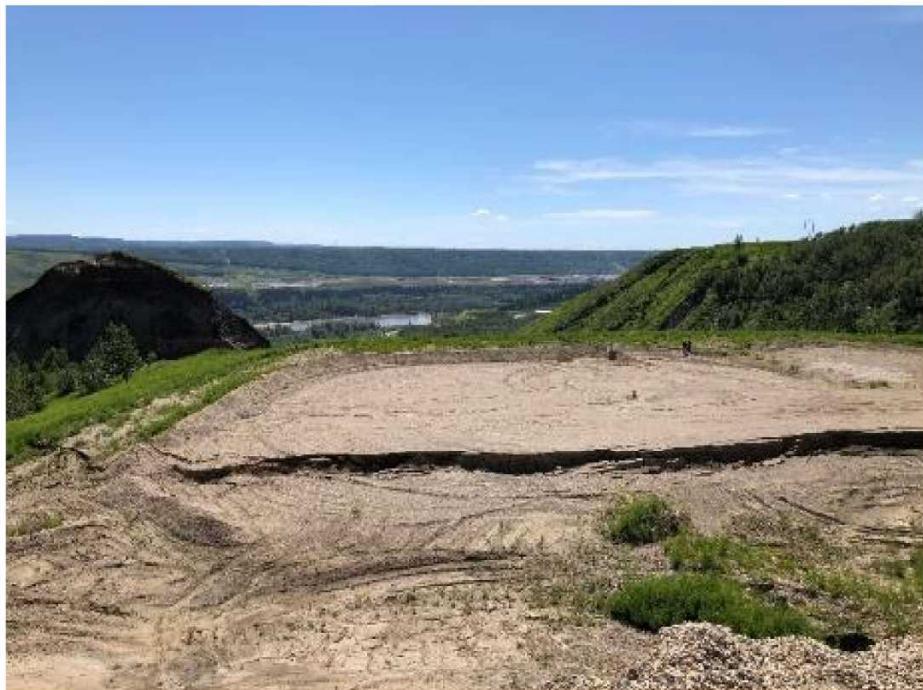
**Photo 20:** Large tension crack crossing the length of the lower borrow pit bench.  
June 24, 2020

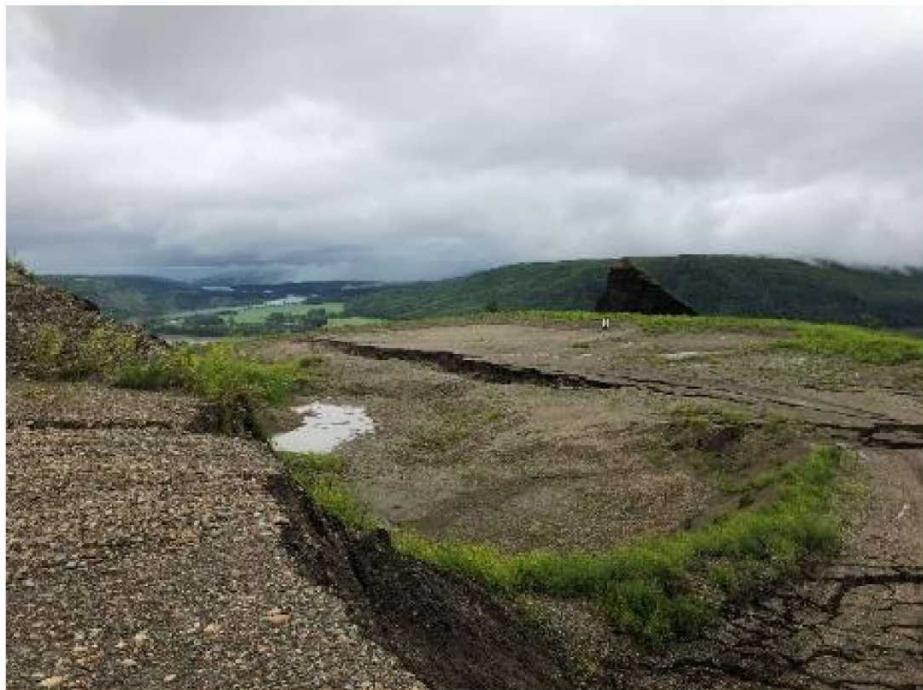
**Photo 24:** View of lower bench in borrow pit (tension crack trends approximately west-east)  
July 3, 2020

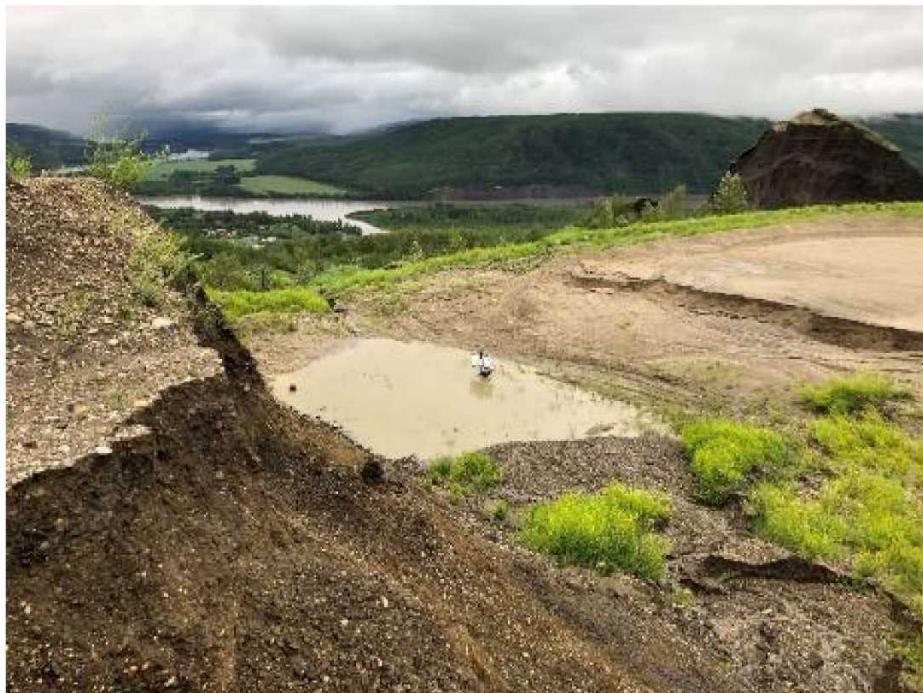
**Photo 25:** Ponded water in graben formed in borrow pit. MoTI GPS unit in pond around GPS unit.

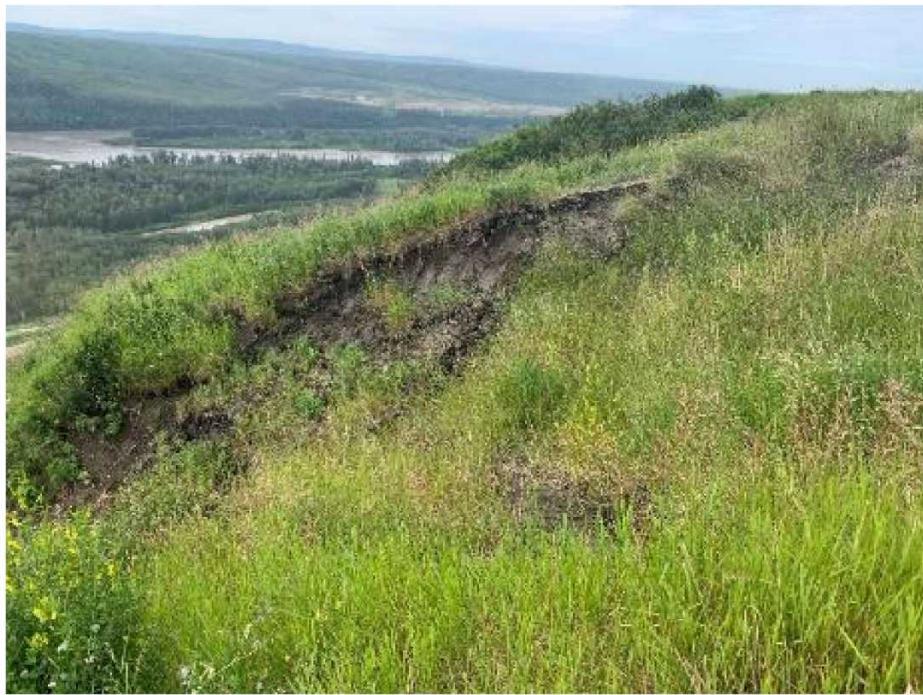
**Photo 27:** Surficial slope instabilities adjacent to viewpoint.  
July 7, 2020

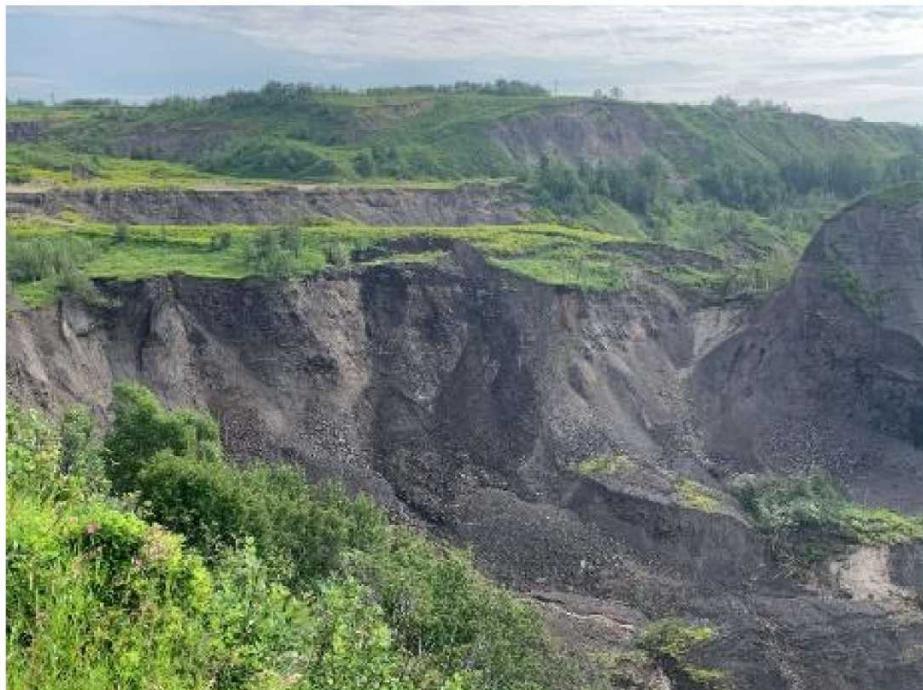
**Photo 28:** Failure of block at main scarp.  
July 7, 2020

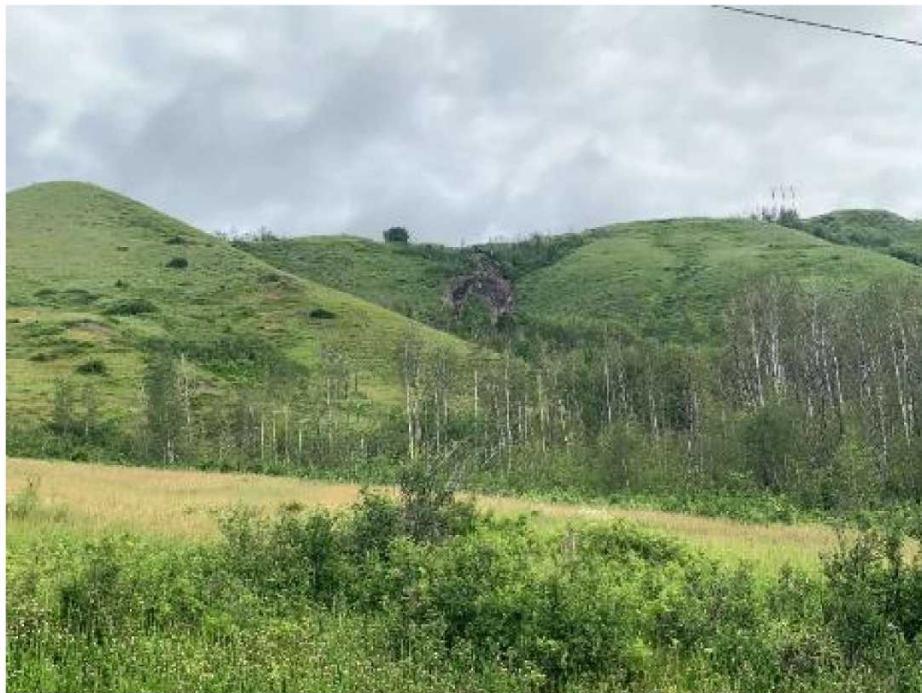
**Photo 31:** Surficial flow failure on south facing slopes west of 2018/2020 landslide .  
July 8, 2020

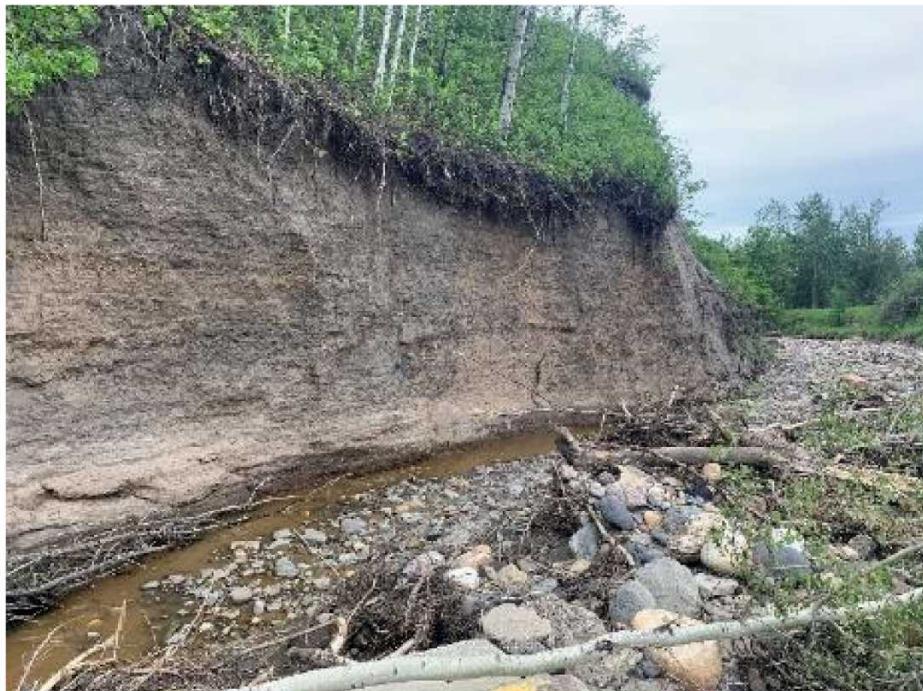
**Photo 39:** Diamicton (clay matrix) deposits exposed by erosion in Bouffioux Creek.  
June 22, 2020

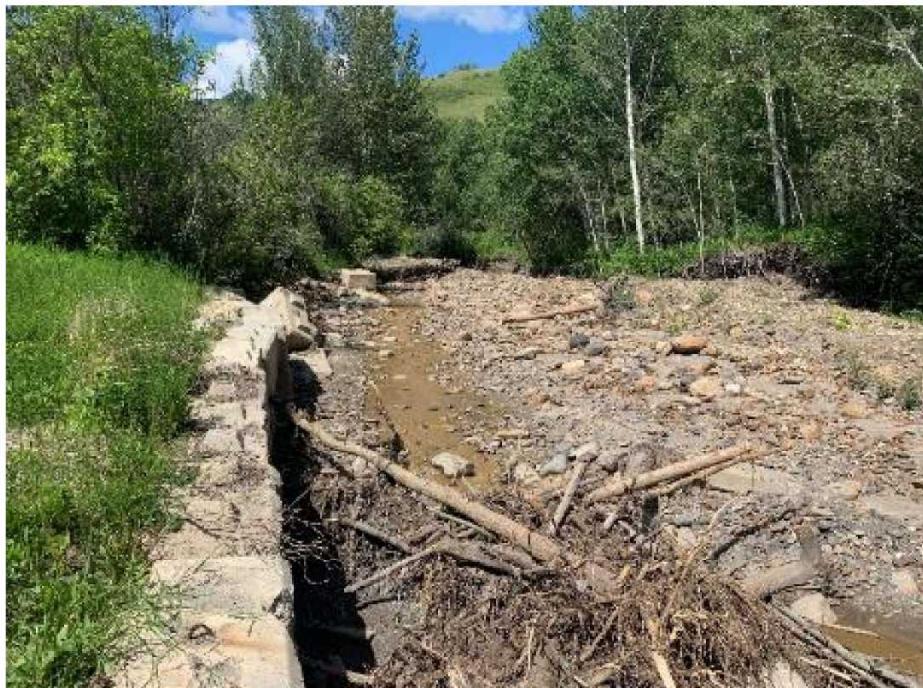
**Photo 40:** Lock block armouring (partially failing) east of Old Fort in Bouffioux Creek.  
June 22, 2020

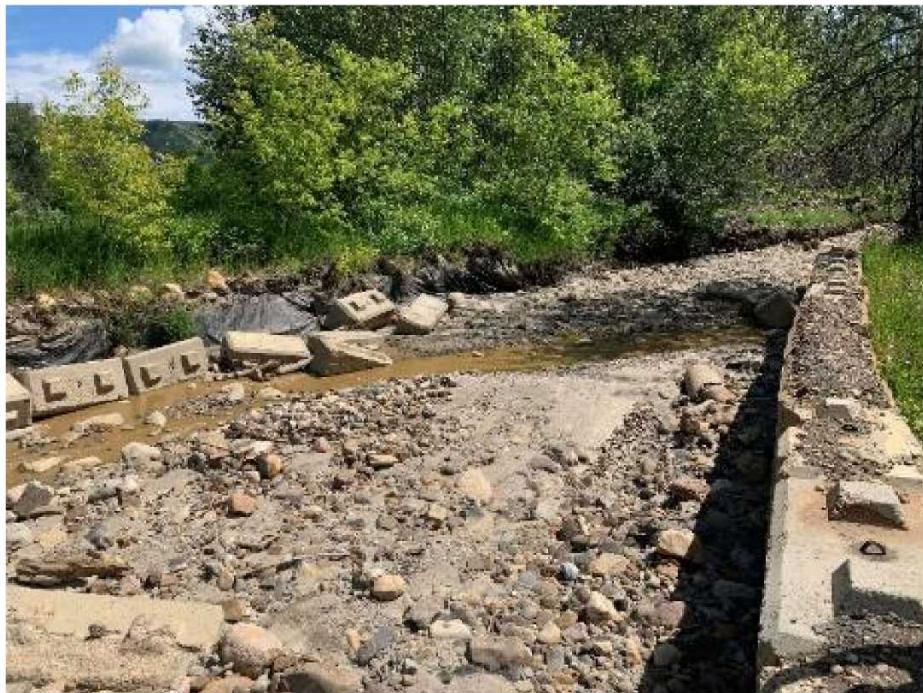
**Photo 41:** Lock block armouring (failing) east of Old Fort in Bouffioux Creek.  
June 22, 2020

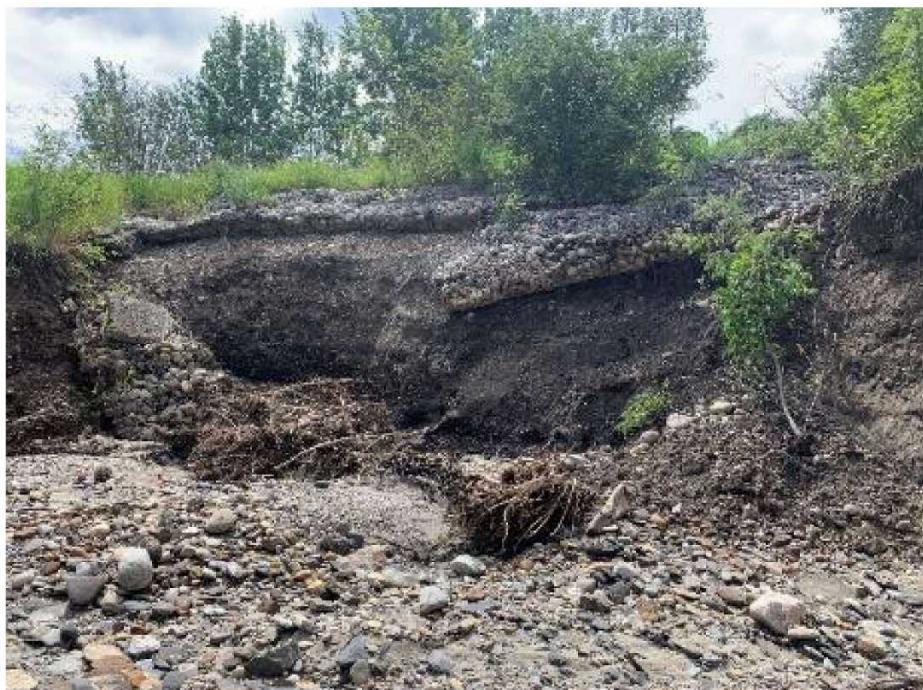
**Photo 46:** Bouffioux Creek bank and gabion basket failure (see Photo 38 for pre-storm picture).  
July 8, 2020

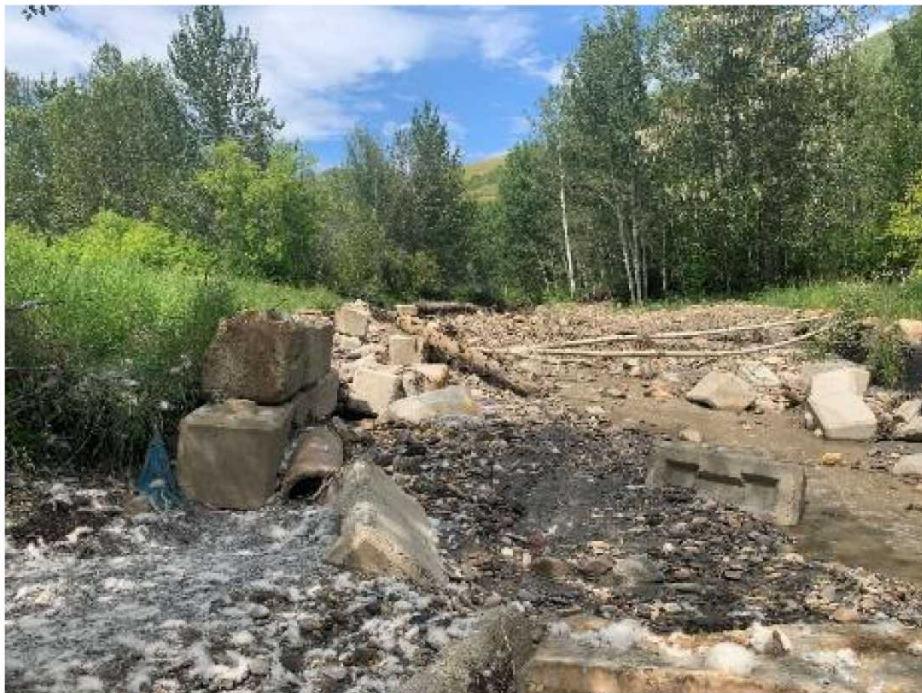
**Photo 47:** Additional failure of the concrete lock blocks in Bouffiox Creek east of Old Fort.  
July 8, 2020

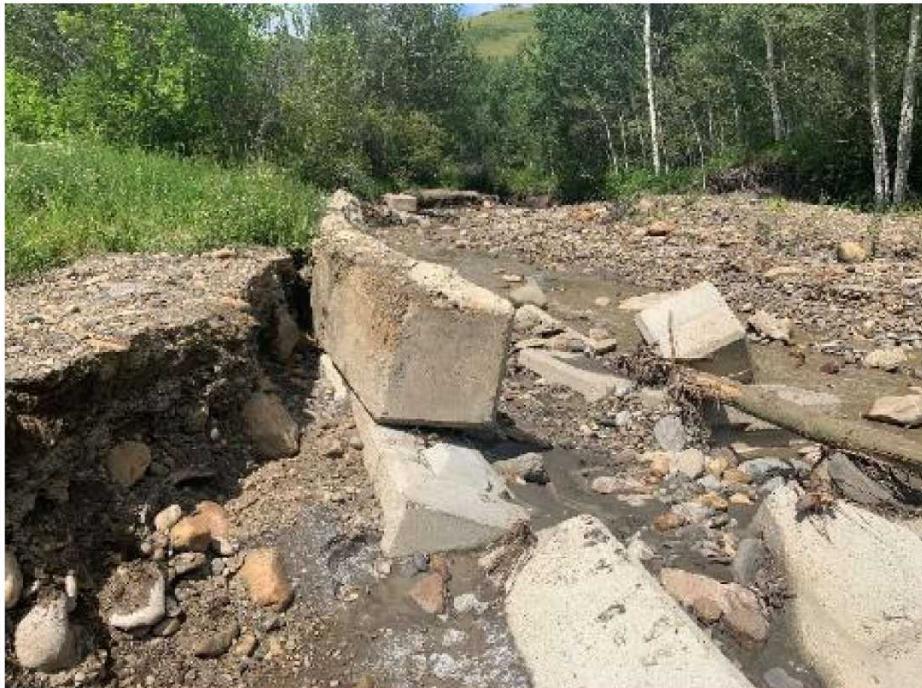
**Photo 48:** Additional failure of the concrete lock blocks in Bouffiox Creek east of Old Fort.  
July 8, 2020
