## Geohazard Assessment of the Old Fort Area

PRESENTED TO  
**Peace River Regional District**

JUNE 24, 2021  
ISSUED FOR USE  
FILE NO. 704-ENG.VGEO3774-01  
REVISION 1

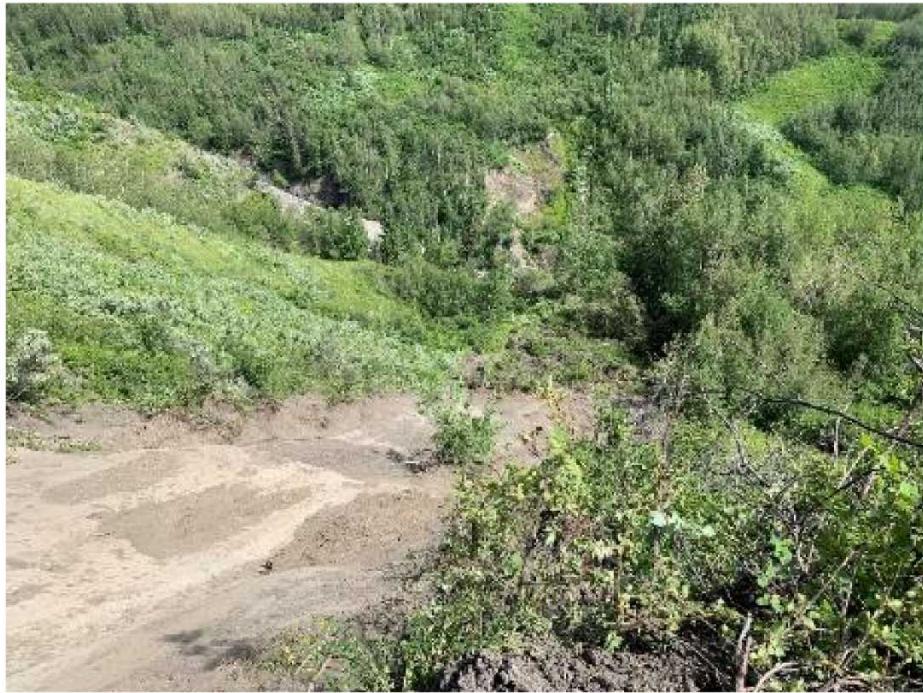
**Photo 49:** Debris Slide failure on west slopes of Bouffioux Creek.  
July 10, 2020

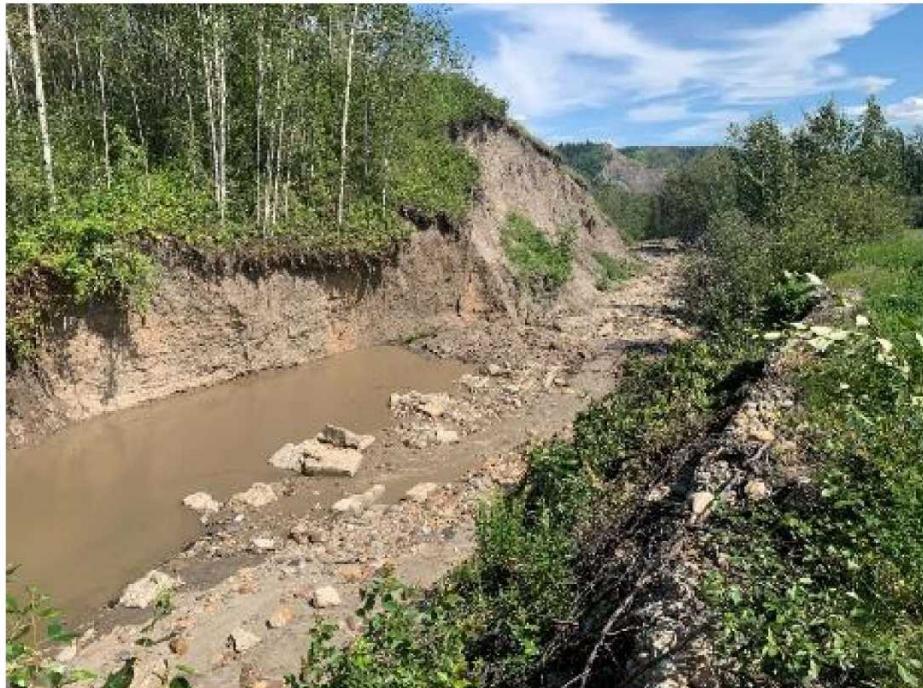
**Photo 50:** Partial blockage/damming of Bouffioux Creek due to debris failure on the inside bend adjacent to Old Fort.  
July 10, 2020

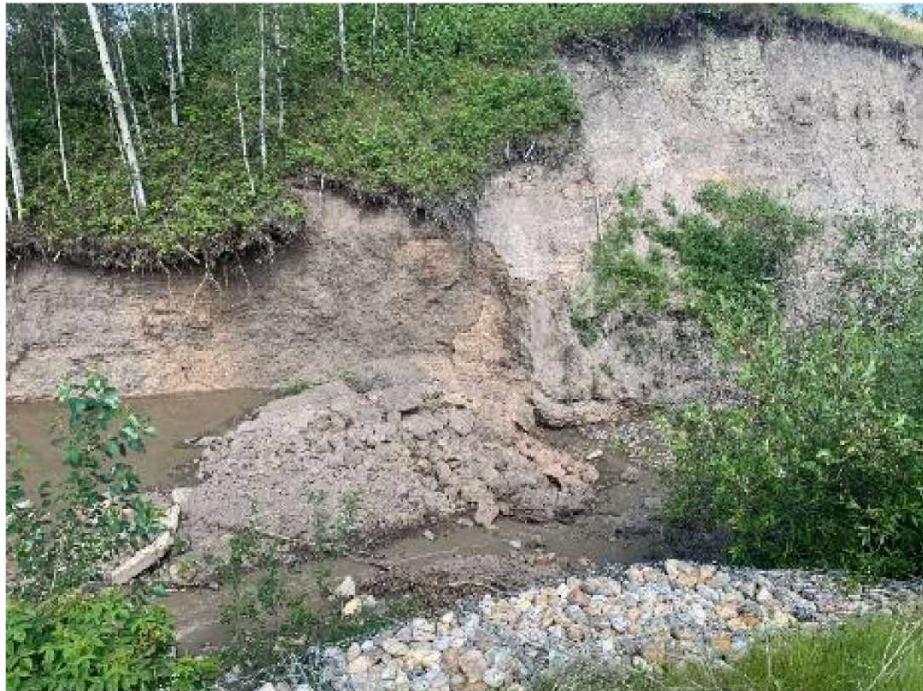
**Photo 51:** Partial blockage/damming of Bouffoux Creek due to debris failure on the inside bend adjacent to Old Fort.  
July 10, 2020
