# Provincial Agricultural Land Commission - Applicant Submission

**Application ID:** 108334  
**Application Type:** Removal of Soil (Extraction) within the ALR  
**Status:** Submitted to L/FNG  
**Name:** Peace Fibre Consulting Ltd.  
**Local/First Nation Government:** Peace River Regional District

# Mine Development and Reclamation Plan

## Peace Fibre Gravel Pit

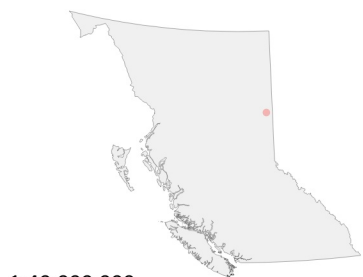
Peace Gravel Pit  
within Sec 24, Twp 82, Rge 17, W6  
Cross-Sectional Profiles

Horizontal Scale 1:4,000

The area subject to this application is located on an elevated alluvial landform within the Peace River Valley. Existing pit conditions indicate that the aggregate deposit extends to approximately 5 m below the ground surface and is underlain by sedimentary bedrock (see Appendix C, Figure 3).

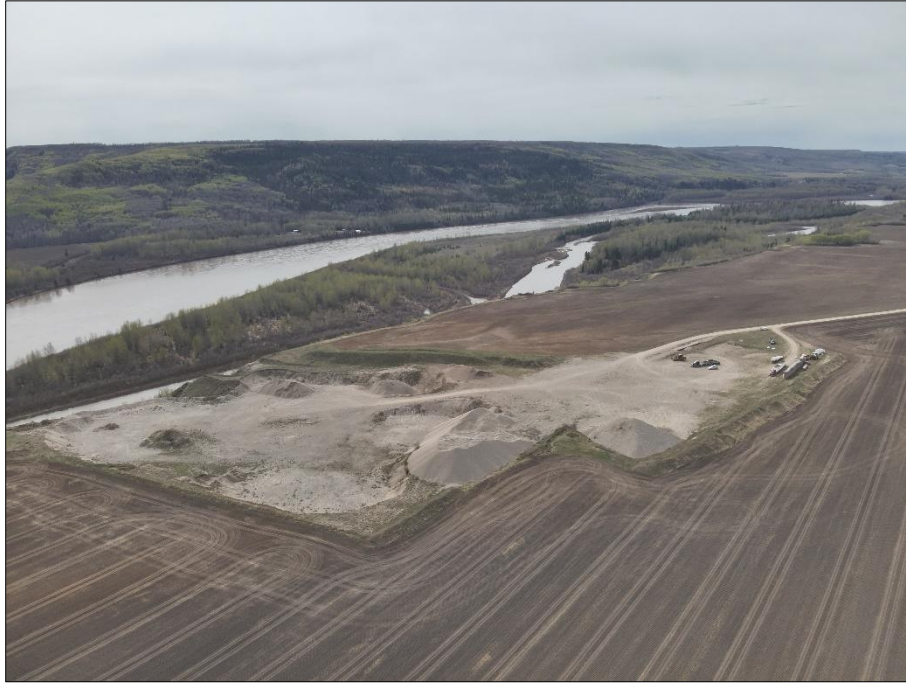
Photo 1: Aerial view of the Peace Gravel Pit, facing southwest.

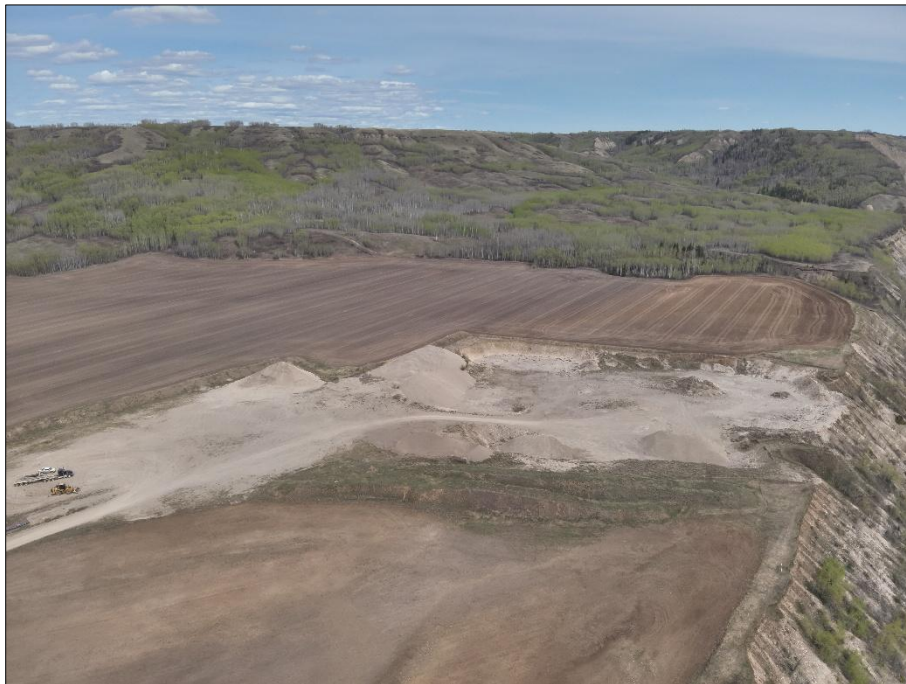
Photo 2: Aerial view of the Peace Gravel Pit, facing northeast.

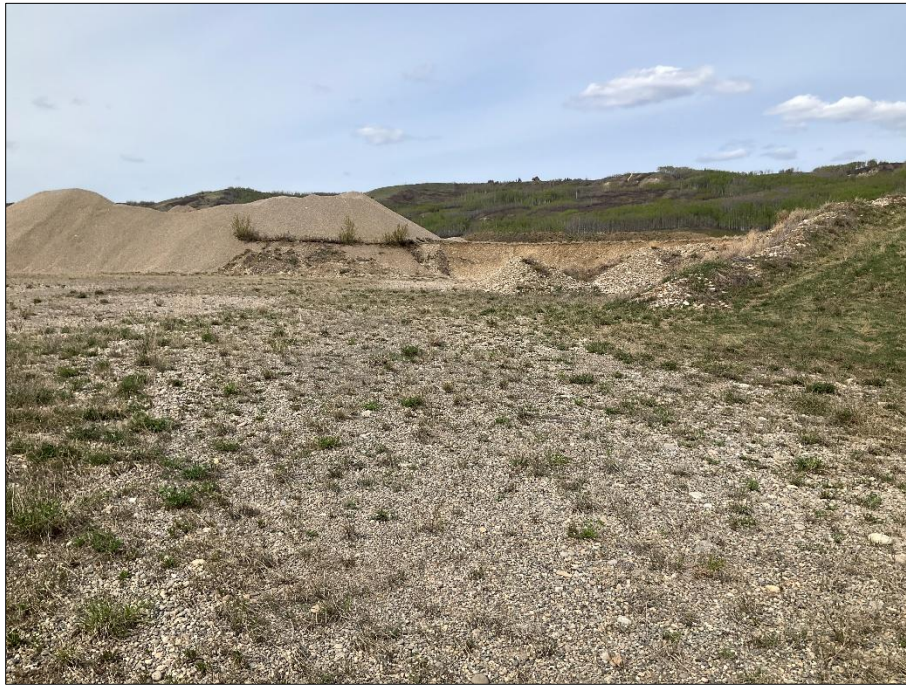
Photo 3: View of the active pit area, facing north.

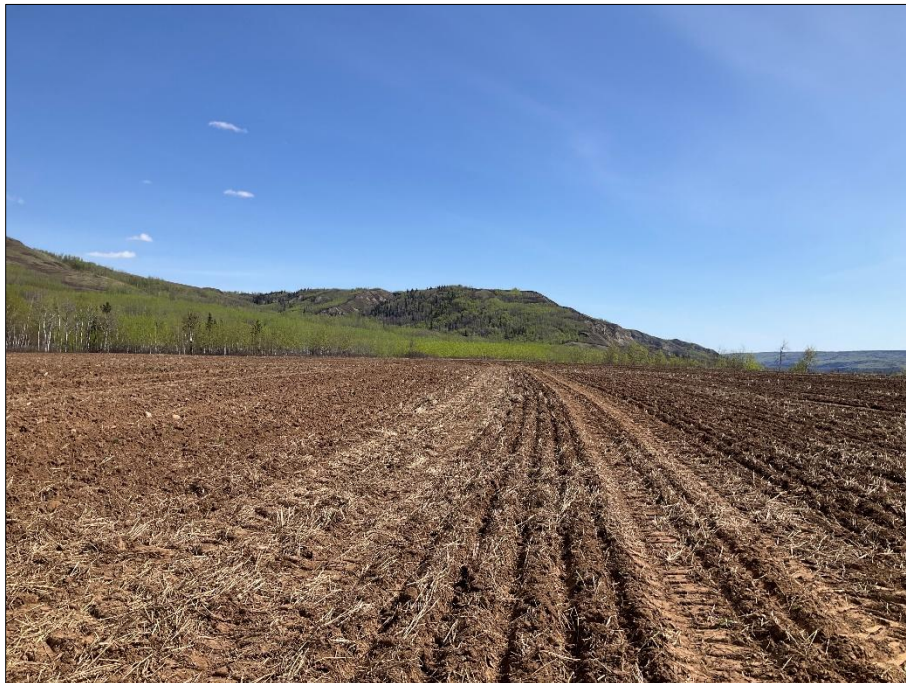
Photo 4: View of the proposed expansion area to the north of the operation area, facing east.

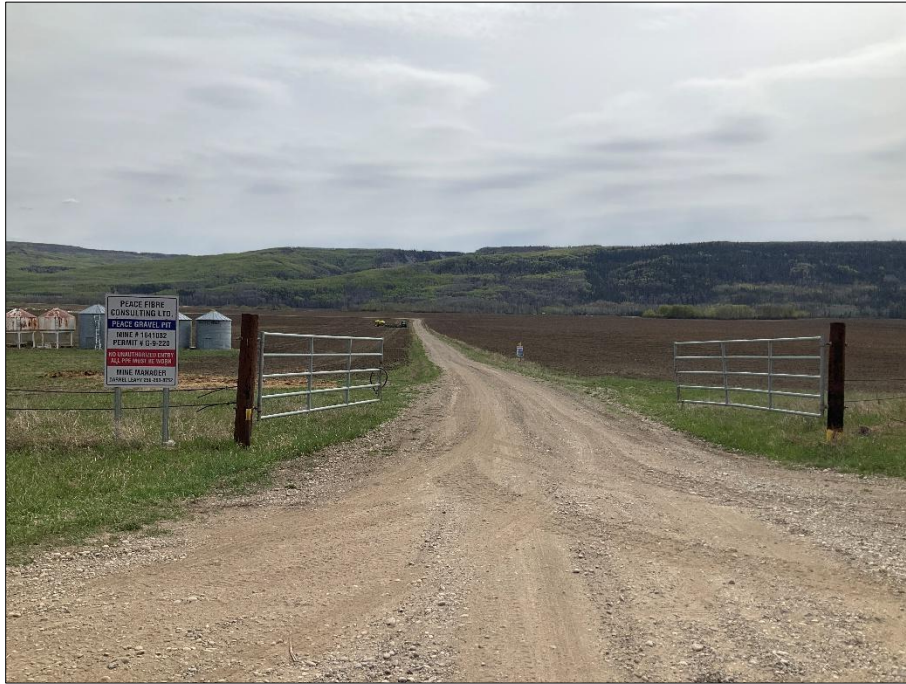
Photo 5: View of the mine entrance gates and signage.

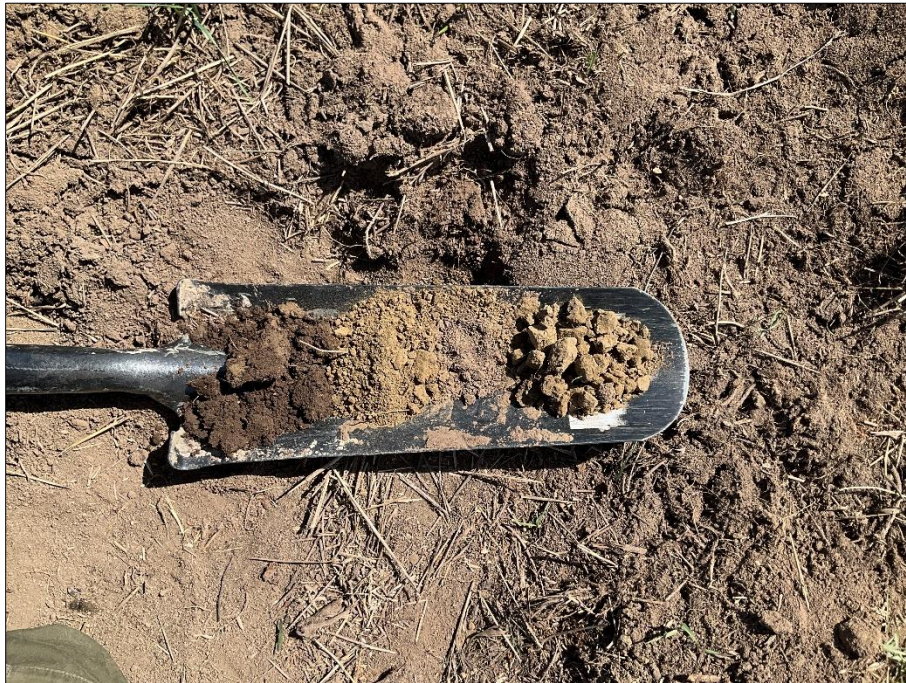
Photo 6: View of the soil profile in the plot located west of the active pit.

Topsoil textures encountered during the field visit were typically silt loams to silty clay loams, with topsoil depth ranging from 17-40 cm (please refer to Table 3 below for a representative soil profile description), and admixing of 5-10 % was observed in one of the soil plots as a result of normal farming practices.

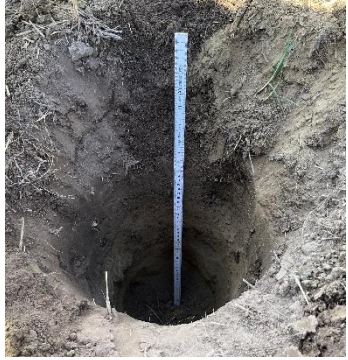
| Assessment Plot | Horizon | Depth (cm) | Colour | Texture | Structure | Mottling | Consistence | Coarse Fragments | Site Characteristics | | Vegetation & Comments | Profile Photo |
|---|---|---|---|---|---|---|---|---|---|---|---|---|
| # 1<br><br>UTM 10<br>654521 E<br>6220453 N | Ap | 0-17 | 10 YR 3/3 | Loam | Sub-angular blocky | None | Loose | - | Slope: | 0 | Alfalfa, canola, lambs quarters, smooth brome | |

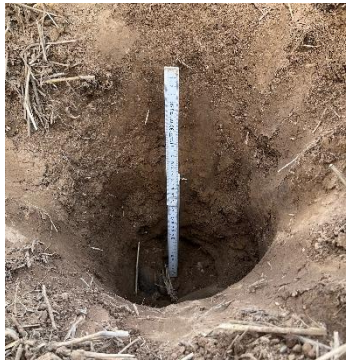
| Assessment Plot | Horizon | Depth (cm) | Colour | Texture | Structure | Mottling | Consistence | Coarse Fragments | Site Characteristics | | Vegetation & Comments | Profile Photo |
|---|---|---|---|---|---|---|---|---|---|---|---|---|
| # 2<br><br>UTM 10<br>654970 E<br>6222433 N | Ap | 0-40 | 10 YR 3/3- | Loam | Granular | None | Friable | - | Slope: | 0 % | Dandelion, lambs quarters<br><br>Auger refusal at 45 cm | |

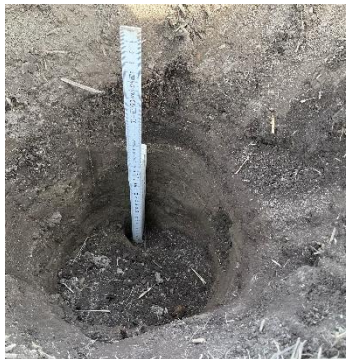
| Assessment Plot | Horizon | Depth (cm) | Colour | Texture | Structure | Mottling | Consistence | Coarse Fragments | Site Characteristics | | Vegetation & Comments | Profile Photo |
|---|---|---|---|---|---|---|---|---|---|---|---|---|
| # 3<br><br>UTM 10<br>654891 E<br>6222624 N | Ap | 0-17 | 10 YR 2/2 | Silt Loam | Granular | None | Friable | - | Slope: | 0 % | Alfalfa, Kentucky bluegrass<br><br>Auger refusal at 41 cm | |

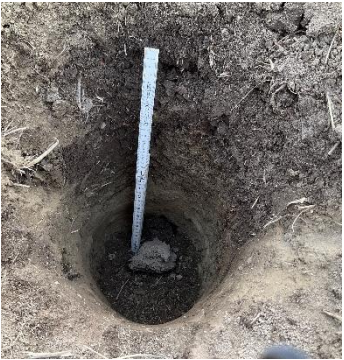
| Assessment Plot | Horizon | Depth (cm) | Colour | Texture | Structure | Mottling | Consistence | Coarse Fragments | Site Characteristics | | Vegetation & Comments | Profile Photo |
|---|---|---|---|---|---|---|---|---|---|---|---|---|
| # 4<br><br>UTM 10<br>654507 E<br>6222767 N | Ap | 0-23 | 10 YR 2.5/3 | Loam | Sub-angular blocky | None | Friable | - | Slope: | 2 % | Kentucky bluegrass, smooth brome<br><br>Auger refusal at 54 cm. | |

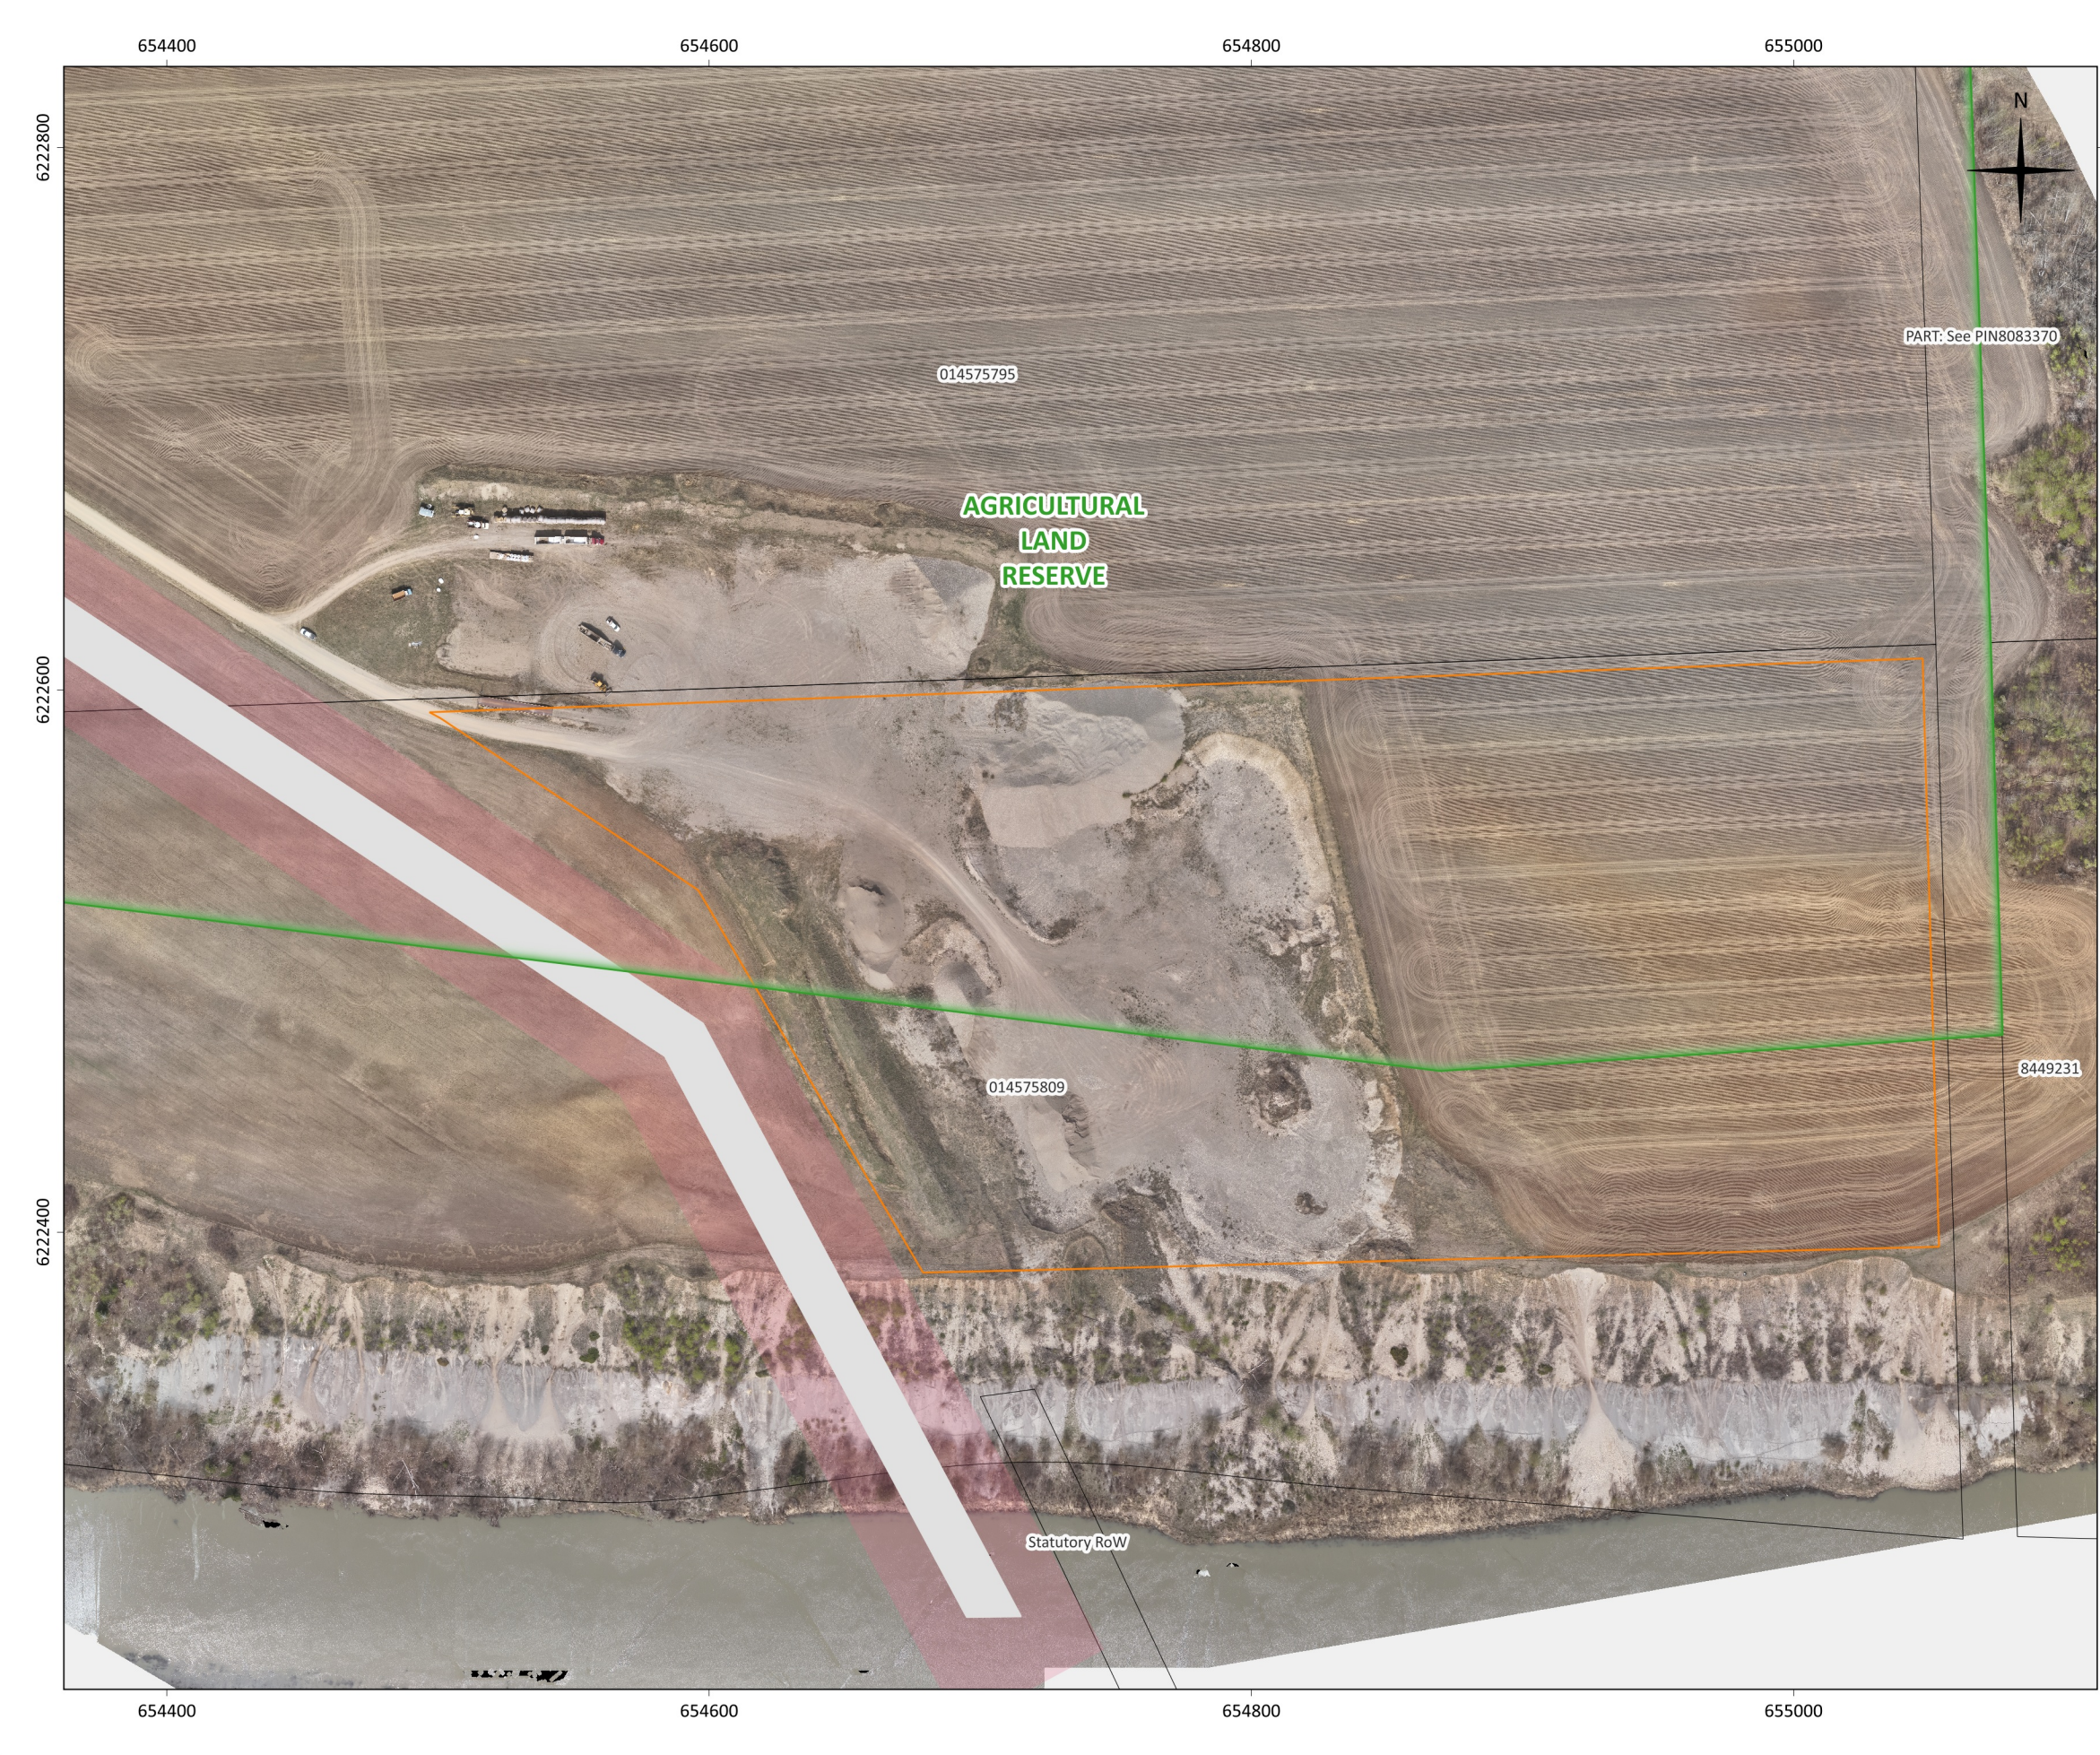
Figure 2

Peace Gravel Pit  
within Sec 24, Twp 82, Rge 17, W6  
Overview - May 8, 2026
