## Geohazard Assessment of the Old Fort Area

PRESENTED TO  
**Peace River Regional District**

JUNE 24, 2021  
ISSUED FOR USE  
FILE NO. 704-ENG.VGEO3774-01  
REVISION 1

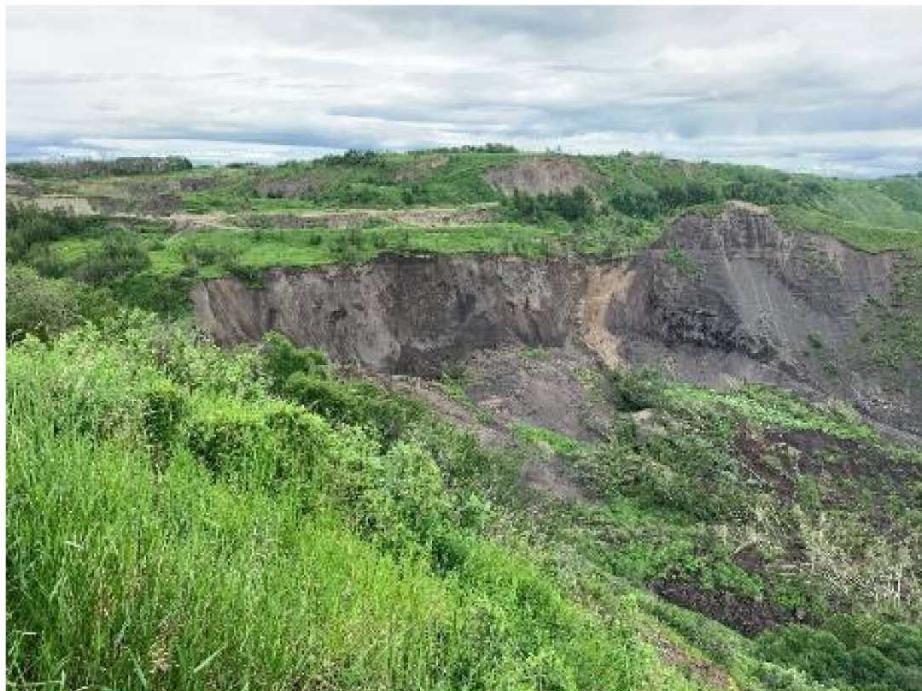
**Photo 5:** Overview of the back-scarp (borrow pit), main scarp (foreground) and ridge.  
Earthflow flowing left to right.

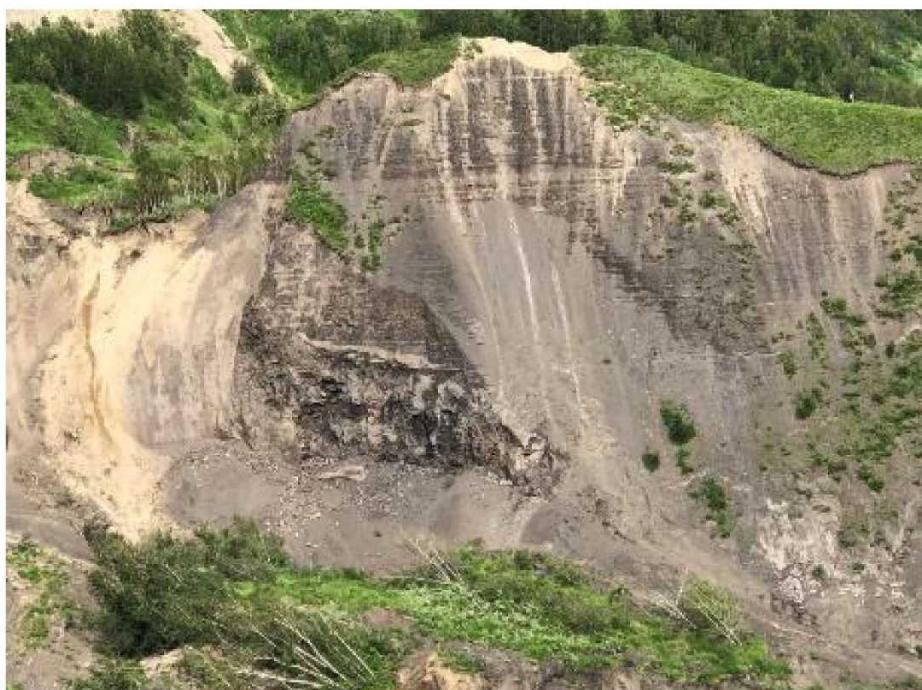
**Photo 6:** Close-up of the bedrock ridge.  
June 20, 2020

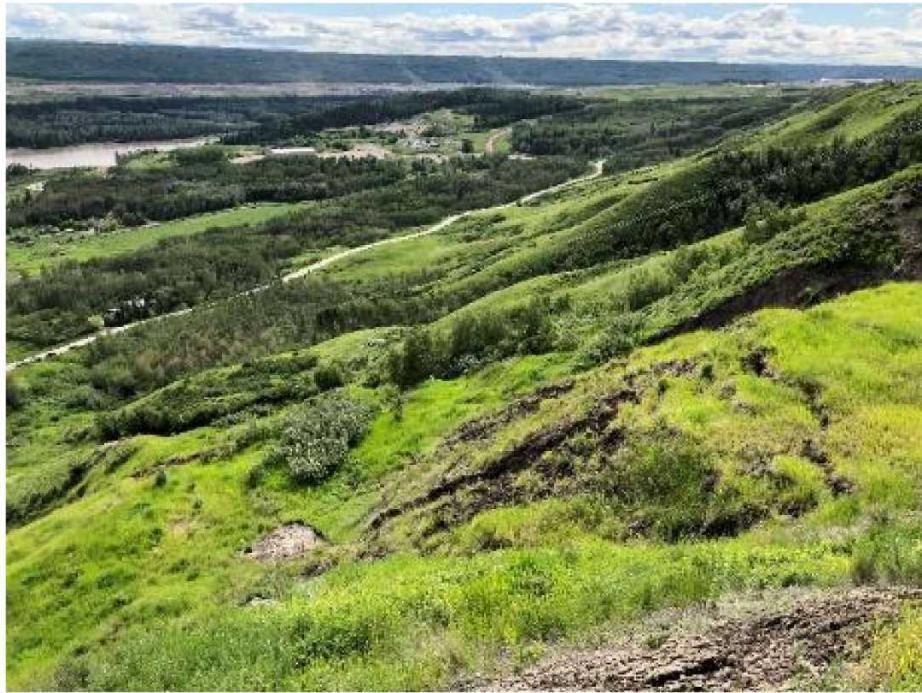
**Photo 7:** Slope relaxation and deformation on the steep slopes near the south end of the look-out.

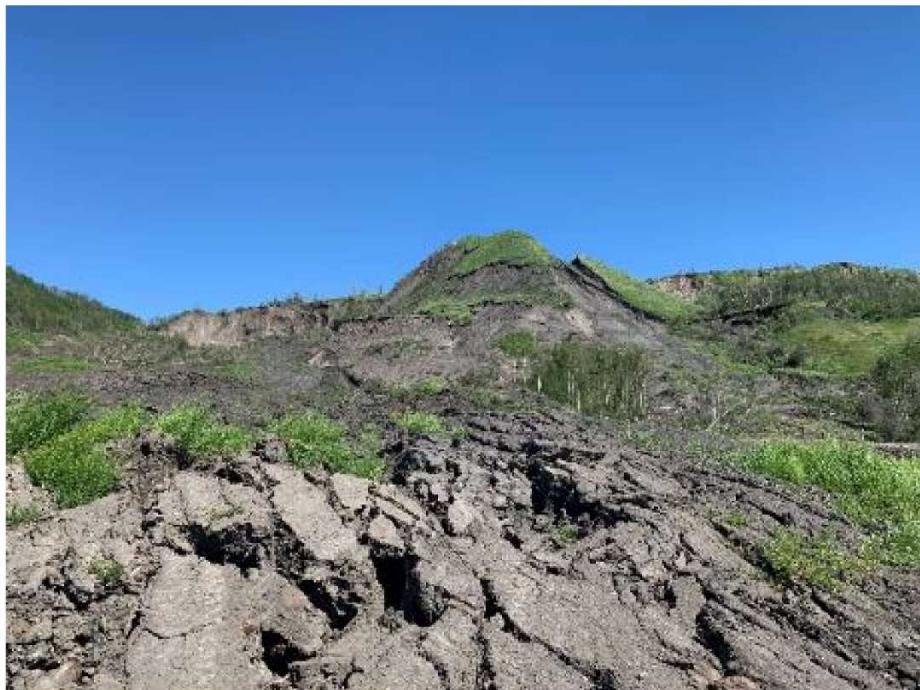
**Photo 10:** Photo taken from on top of the earthflow looking up/north towards the main scarp and bedrock ridge.  
June 21, 2020

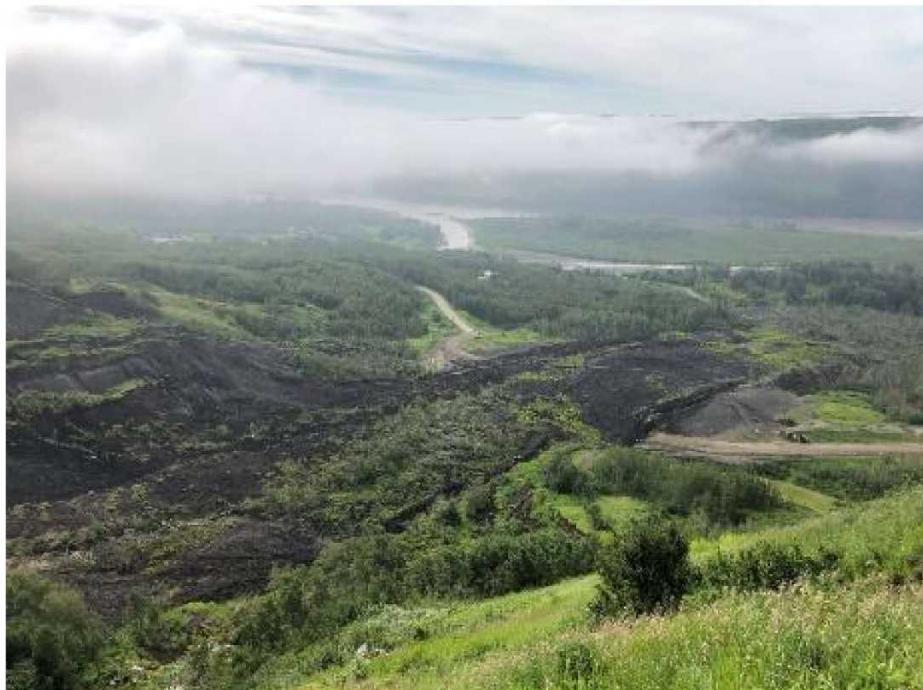
**Photo 22:** View of earthflow and Old Fort Road from viewpoint.  
June 29, 2020

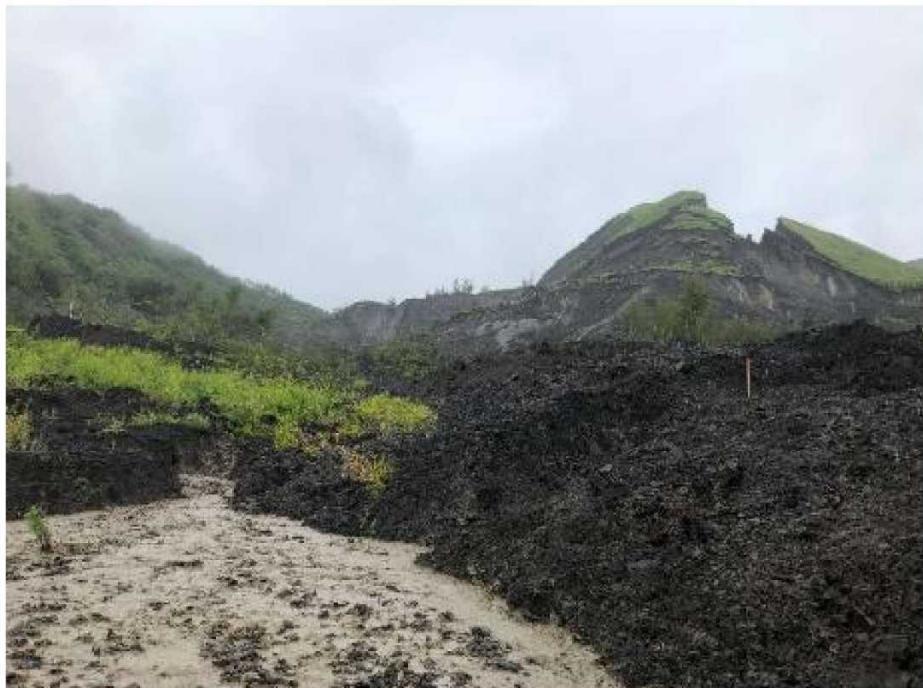
**Photo 26:** Surficial water flows through the earthflow mass after high precipitation event.

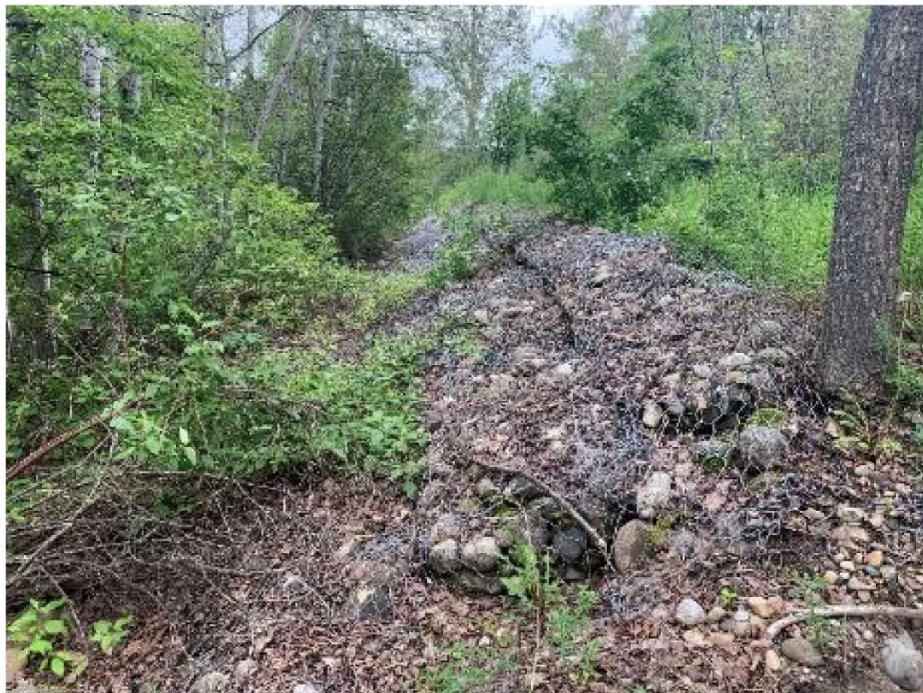
**Photo 35:** Gabion baskets at west end of Bouffiox Creek dike.  
June 22, 2020

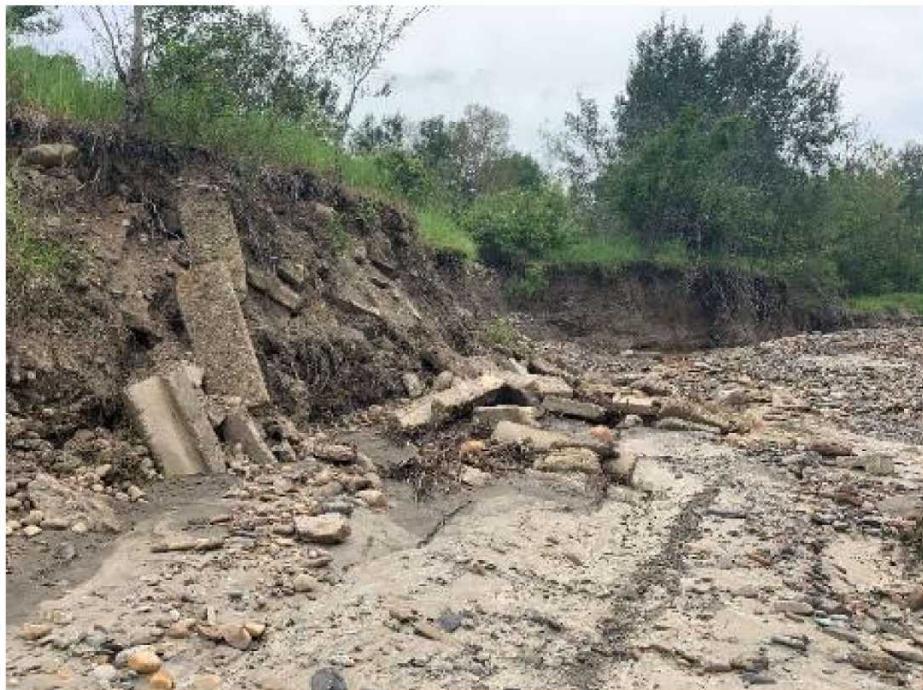
**Photo 36:** Concrete no post barriers dumped into Bouffiox creek adjacent to residential area.  
June 22, 2020

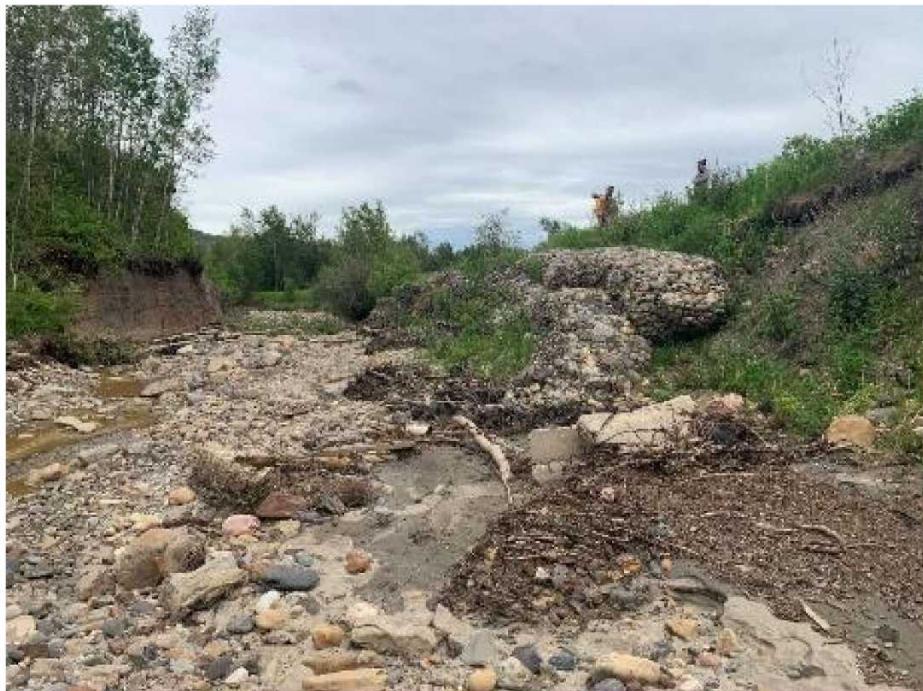
Damage to the dike infrastructure and lock blocks erosion protection of the lower reaches of Bouffioux Creek was observed during the field reconnaissance. The gabion baskets used for erosion protection on the upstream dike face have failed into the creek bed in several locations. Photos 38 and 46 in Appendix C show pre and post dike failure of a location adjacent to Old Fort. Concrete lock blocks and no-post barriers were observed in multiple locations throughout the stream bed, it is assumed they were transported by large water flows.

**Photo 37:** Gabion baskets partially in Bouffiox Creek near residential area (looking downstream).

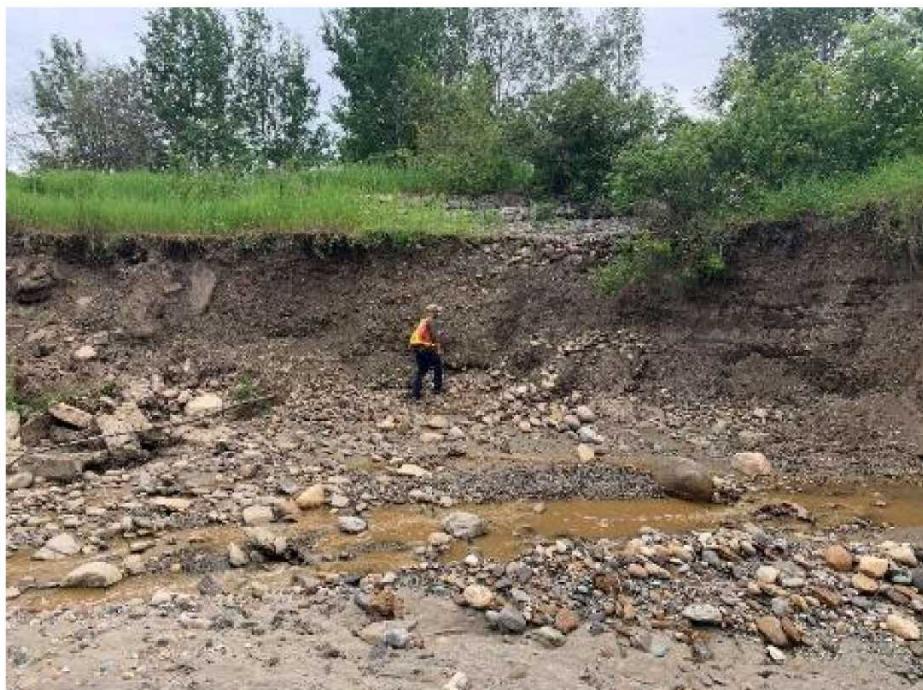
**Photo 38:** Tetra Tech inspecting banks of Bouffiox Creek and dike (pre-failure at this location)

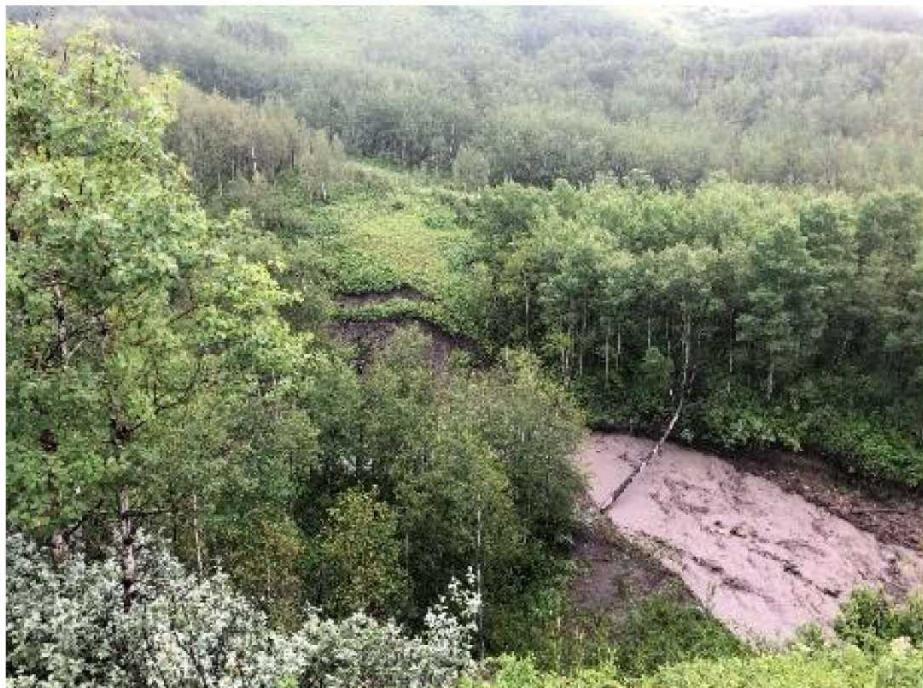
**Photo 42:** High creek flows in Bouffioux Creek following high precipitation event.  
July 3, 2020

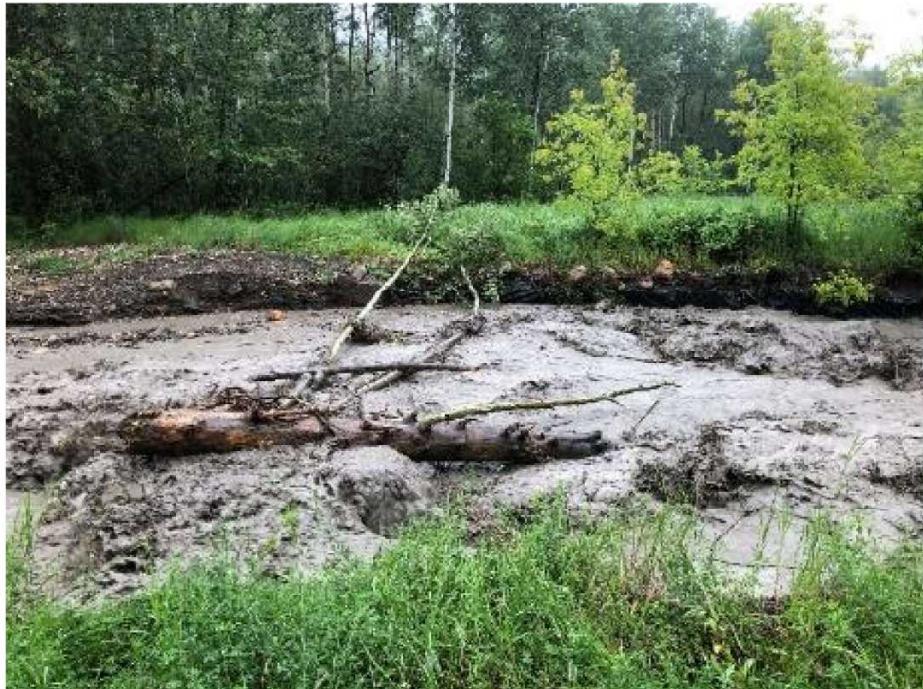
**Photo 43:** Debris in Bouffiox Creek near lock blocks east of Old Fort  
July 3, 2020

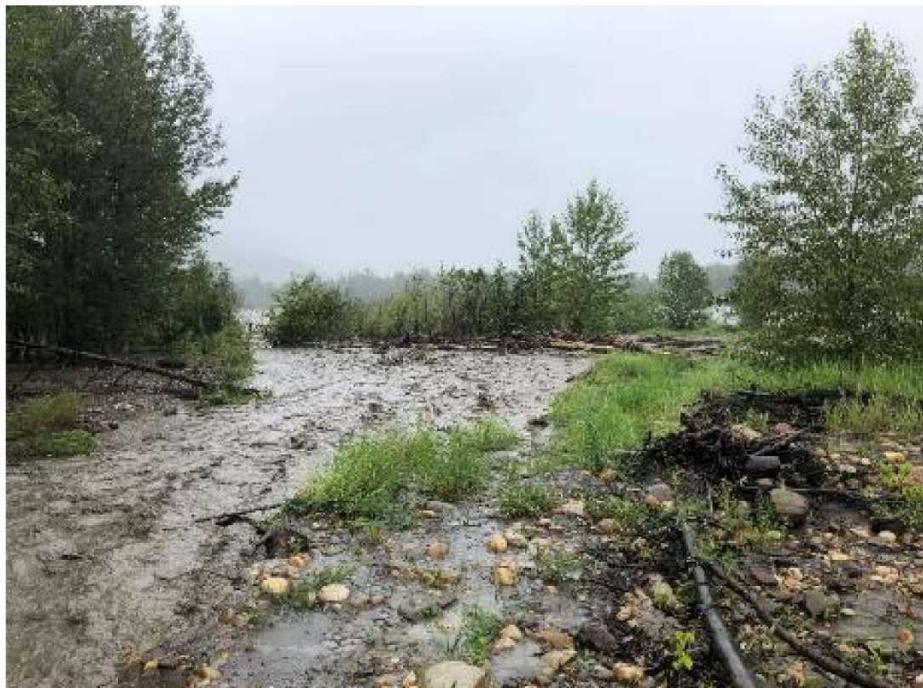
**Photo 44:** Localized flooding and pile of debris at confluence of Bouffiox Creek and Peace River.  
July 3, 2020

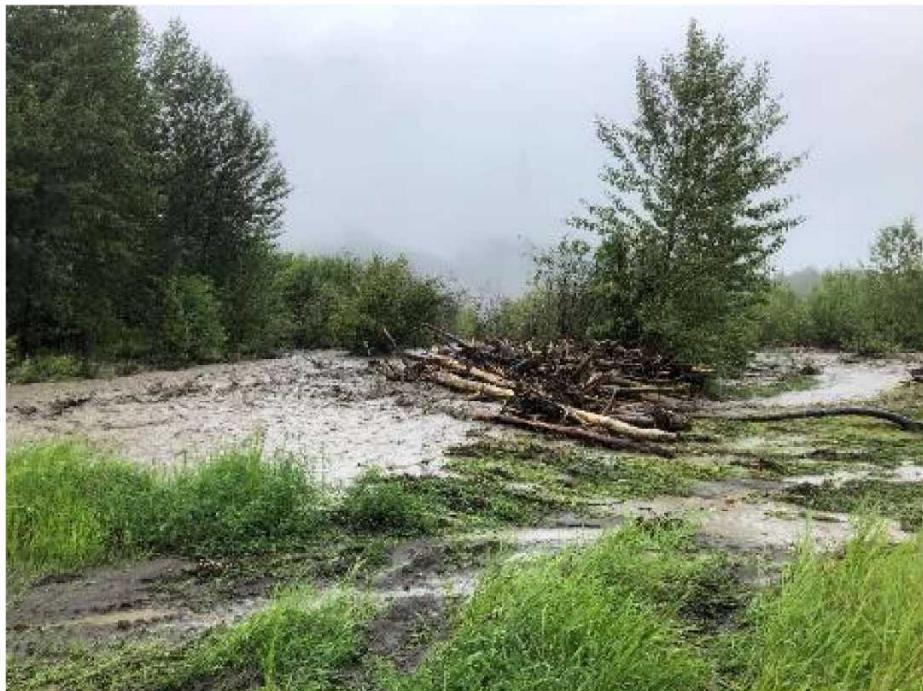
**Photo 45:** Localized flooding and debris accumulation at confluence of Bouffioux Creek and Peace River.  
July 3, 2020

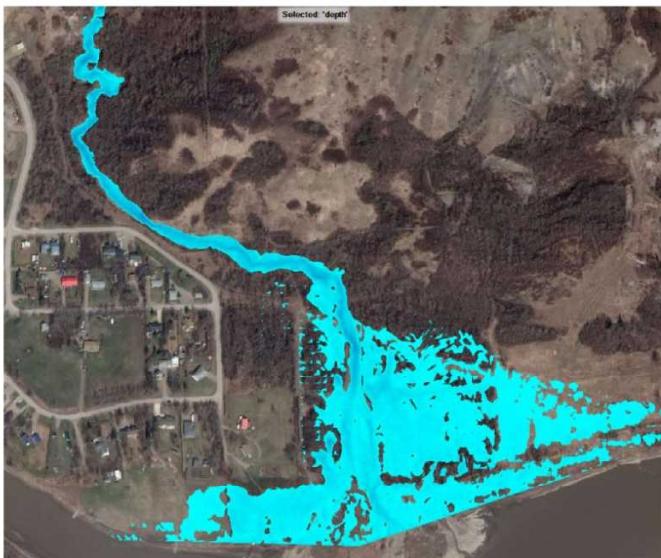
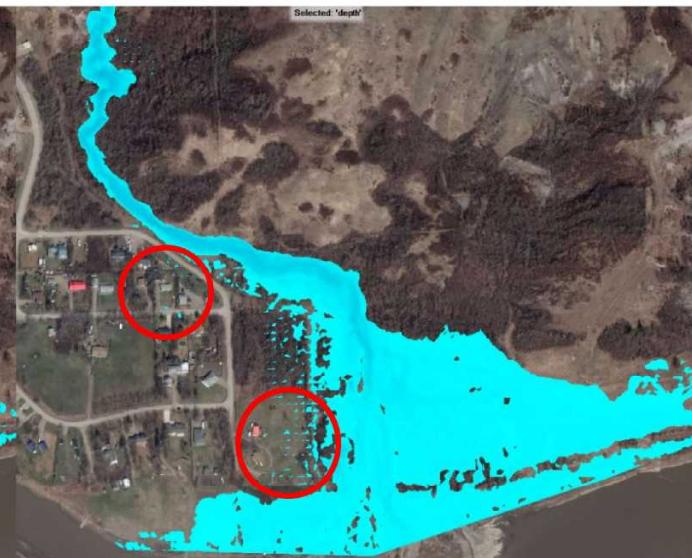
**Figure 5. Hydraulic modelling for clearwater case (left), and sediment-bulked case using bulking factor of 2.0 (right)**

Using the SCS Type II 12-hr 1-in-200-year storm event, it was found that no significant flooding occurs in the Old Fort Area for a clearwater case (Figure 5, left). In this case, the water level is predicted to be approximately 1.7m below the crest of the existing dike. However, by including the effect of debris bulking on the creek inflow, it was found that flooding is predicted to appear south of the banks of the creek in the Old Fort Area. (Figure 5, right)

Tetra Tech observed ongoing erosion and sloughing along the banks of the creek while on site in June/July 2020, including shifting of the gabion baskets and concrete lock blocks. If no action is taken, the ongoing erosion in Bouffiox Creek will make a debris-bulked flooding scenario more likely in the future and may worsen over time as Fort St. John continues to develop and urbanize the upstream land, coinciding with the stormwater system upgrades to increase discharge into the creek.
